# Johnson Creek Watershed Flood Resiliency Project

## *Final Report*

Municipal Vulnerability Preparedness (MVP) Program Grant 2021, RFR ENV 22 MVP 02

**Town of Groveland**

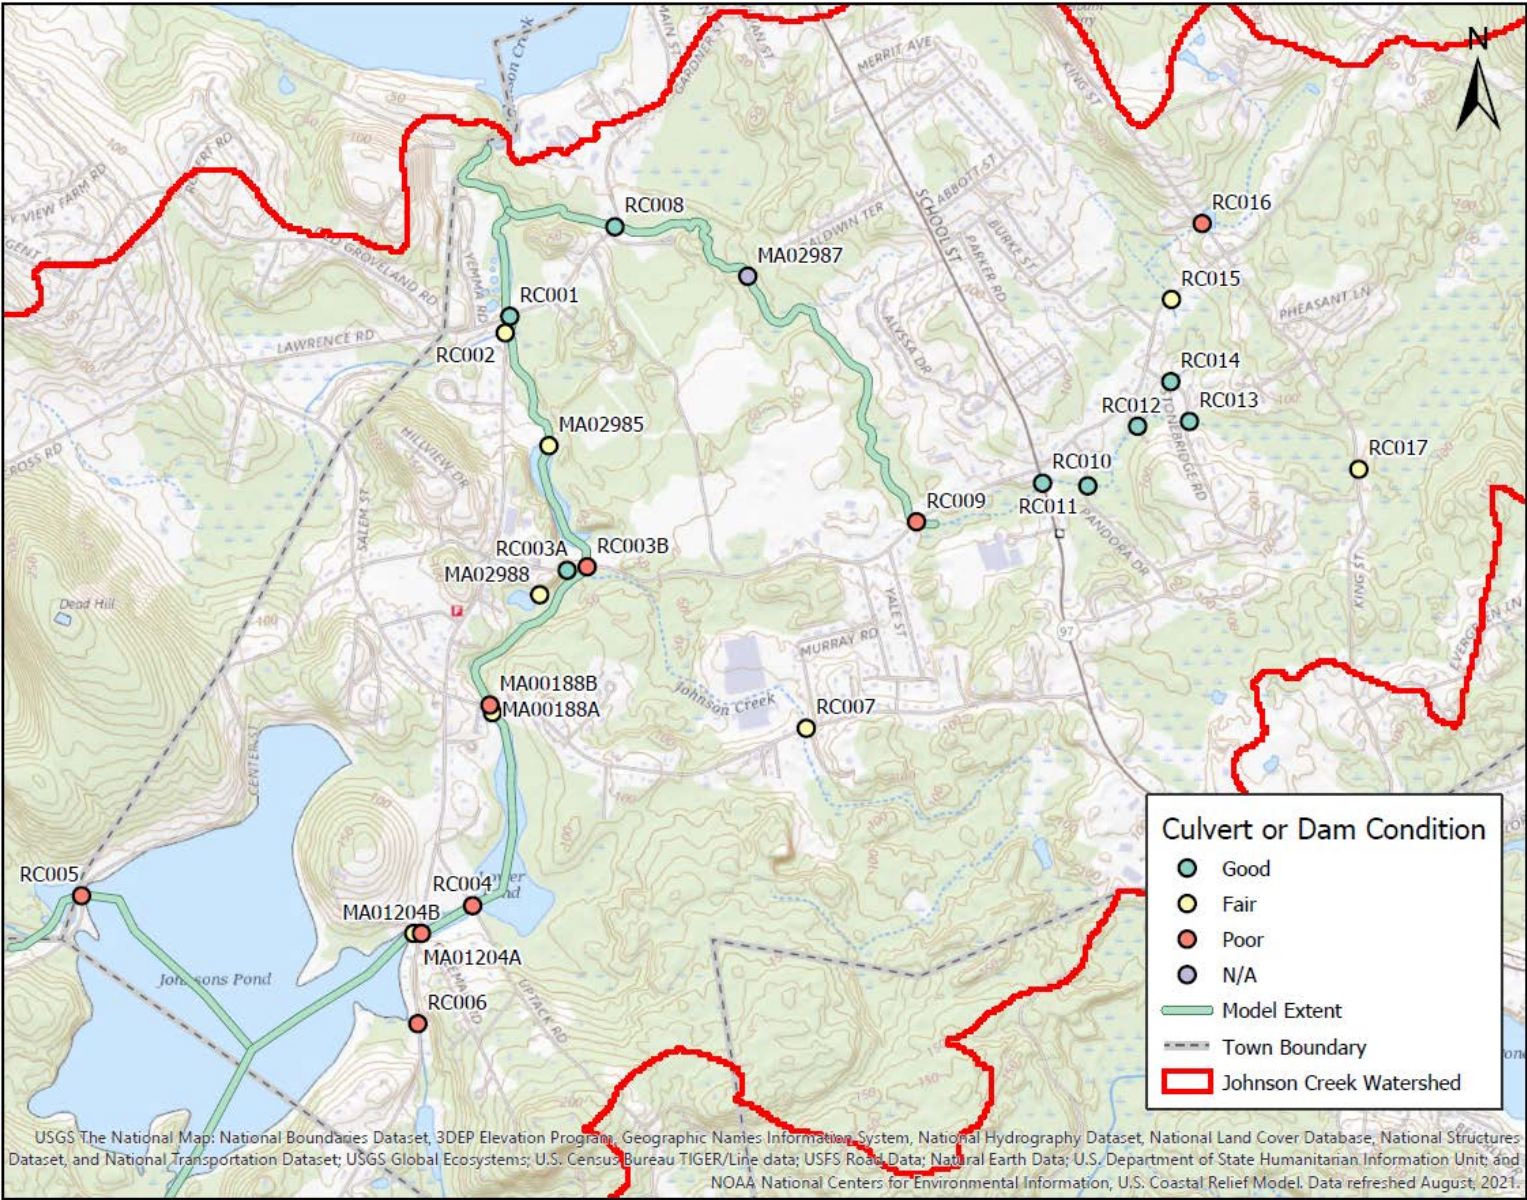
Figure 2-2. Condition Observations

- Condition: Qualitative condition for assessed locations ranged from “Good” to “Poor”. Typical reasons for observed “Poor” conditions were structural damage (e.g., deterioration, collapsing, etc.) potentially caused by age, stream instability, beaver activity, or other factors.

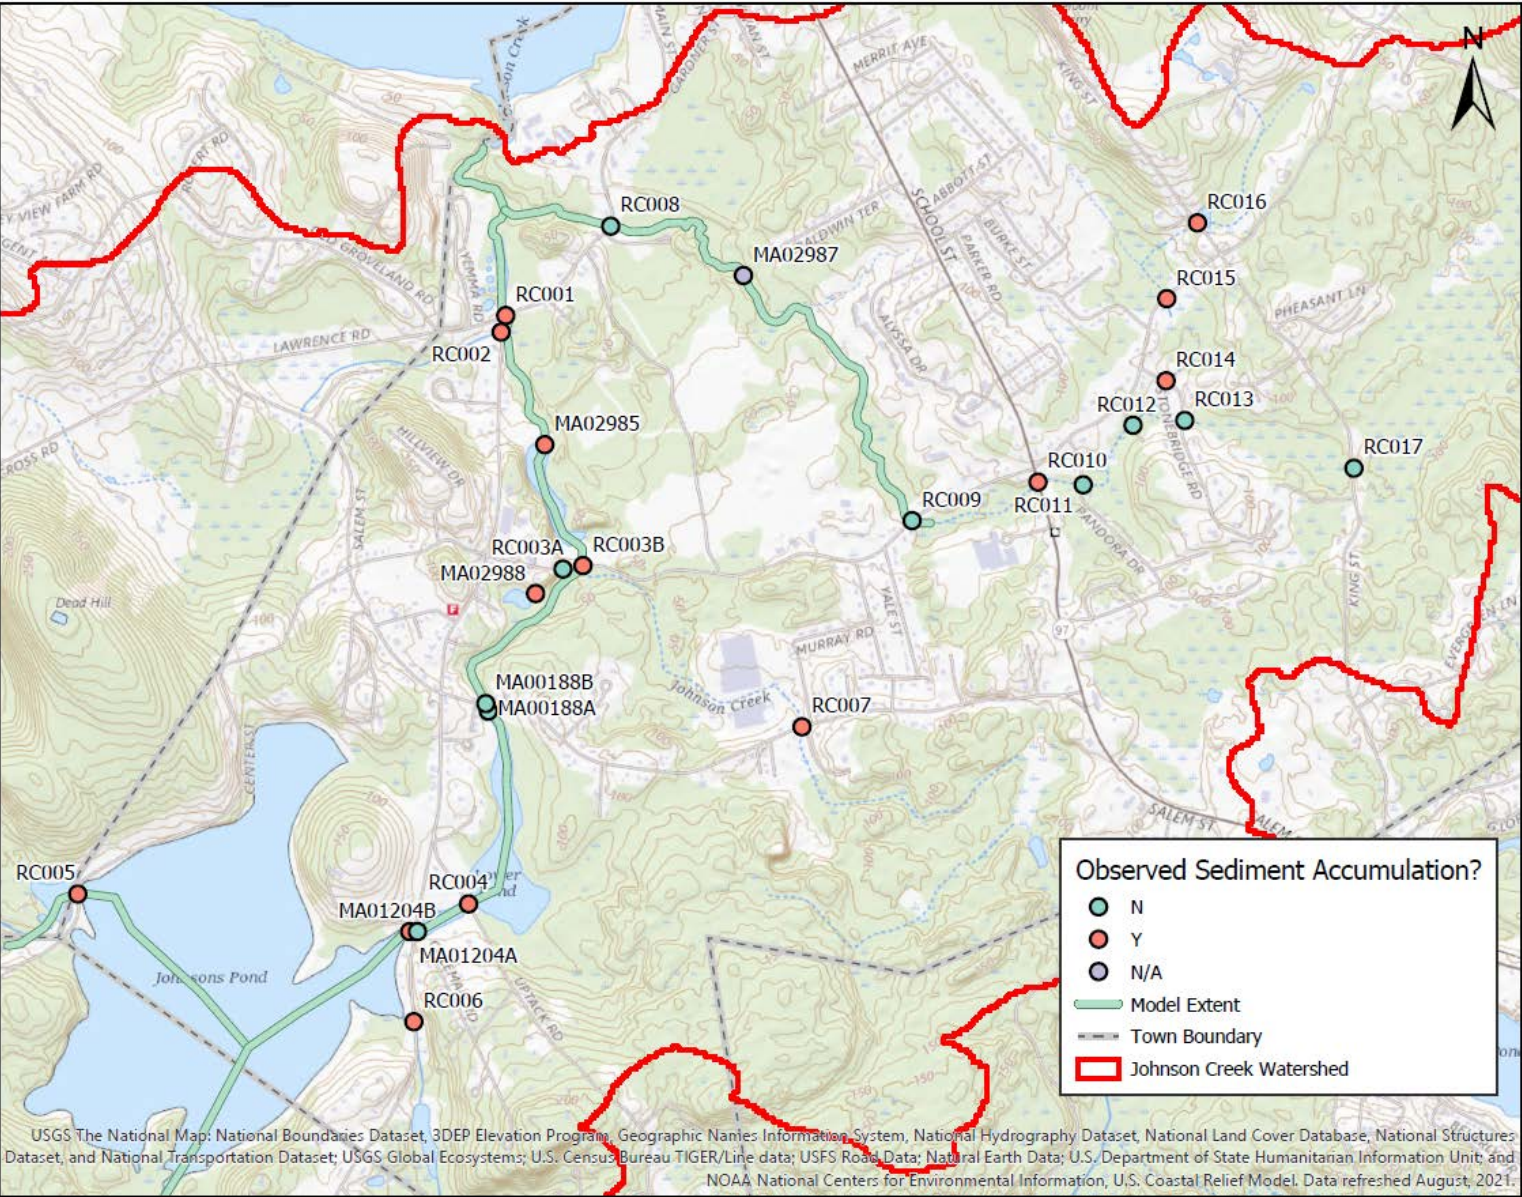
Figure 2-3. Sedimentation Observations

- Sedimentation: As is typical of most New England towns, sedimentation of drainage features (i.e., culverts, channels) was observed throughout the watershed. Sediment buildup was typically less than 10% relative to culvert or channel capacity, but approached 25% at some locations (e.g., RC014). The primary cause of sedimentation is likely eroded material (or material from roadways) that settle upstream of in-stream hydraulic structures (e.g., culverts or dams) that create depositional backwater conditions.

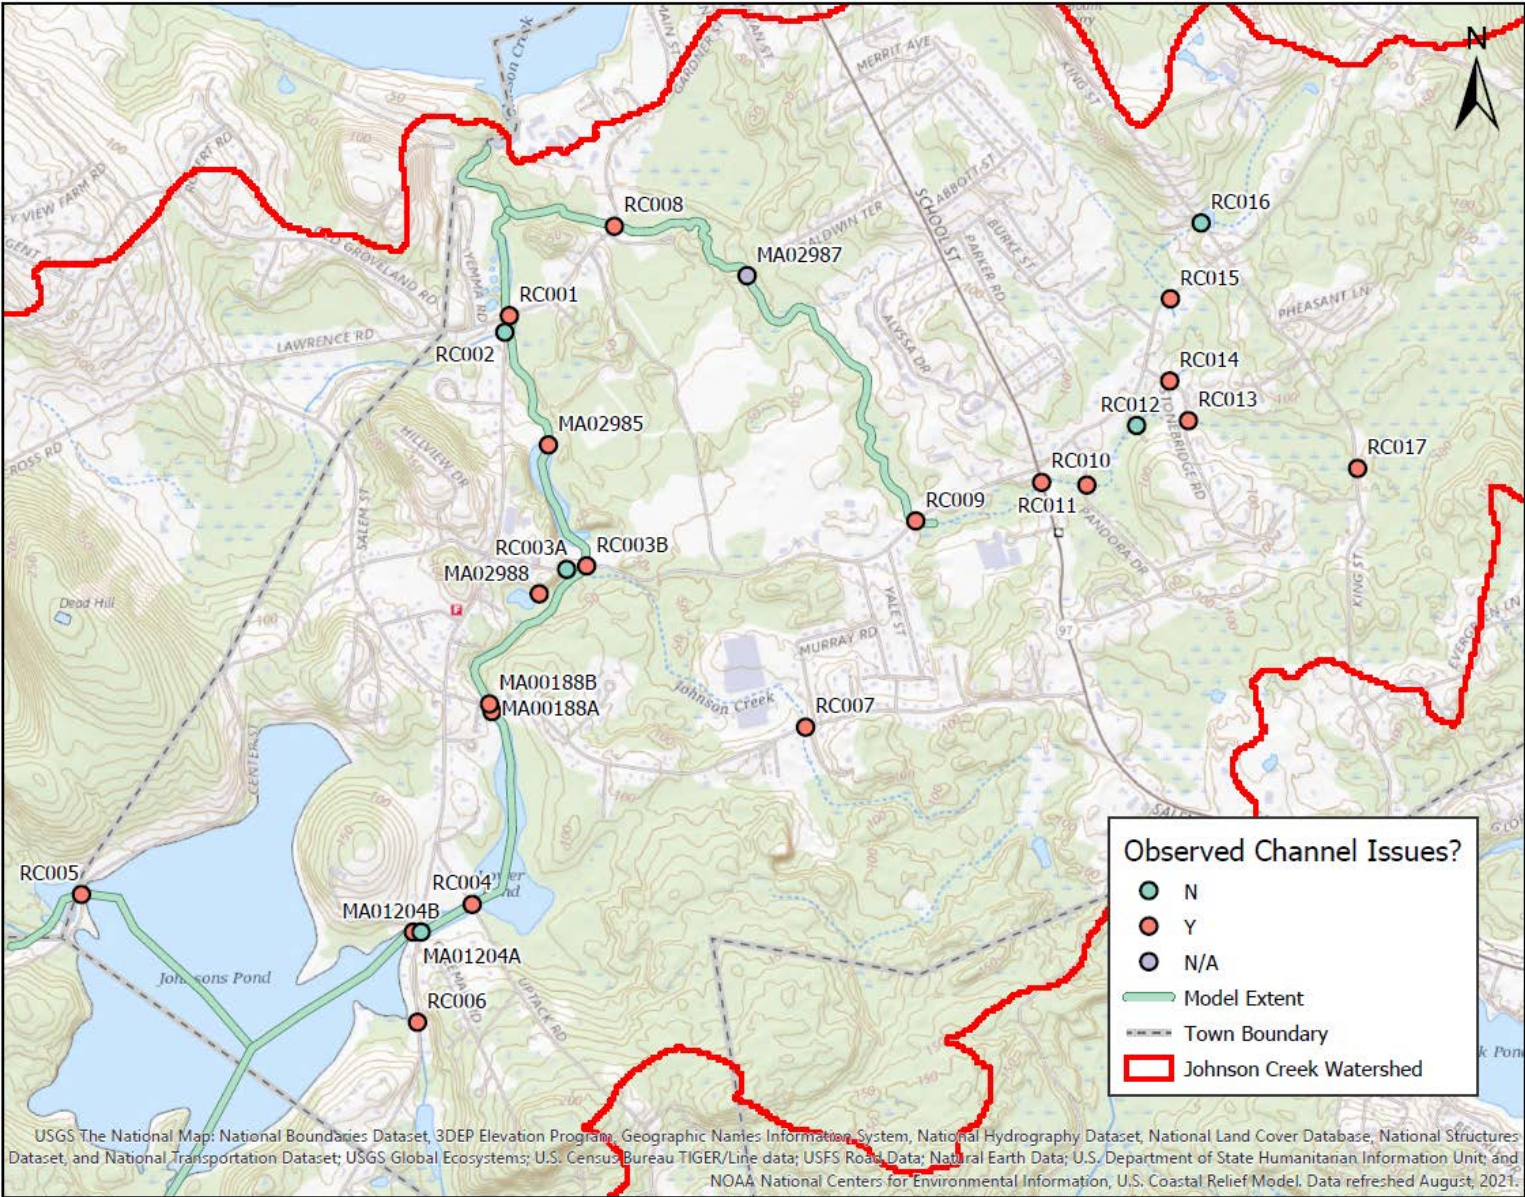
Figure 2-4. Channel Observations

- Channels: Most visited channels had some observed issues. Commonly observed issues included sedimentation, debris blockage, beaver activity, and channel instability (i.e., erosion). The primary cause of erosion is likely high velocity flows in erodible channels caused by upstream impervious surfaces, inadequate riparian buffers, or reduced natural floodplain.

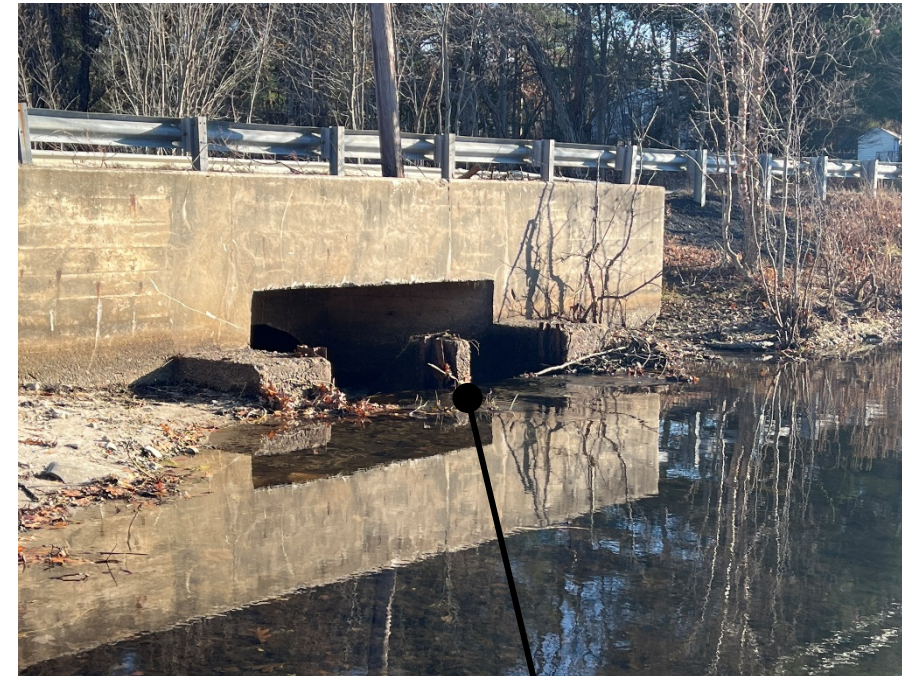
Deteriorating Outlet Structure

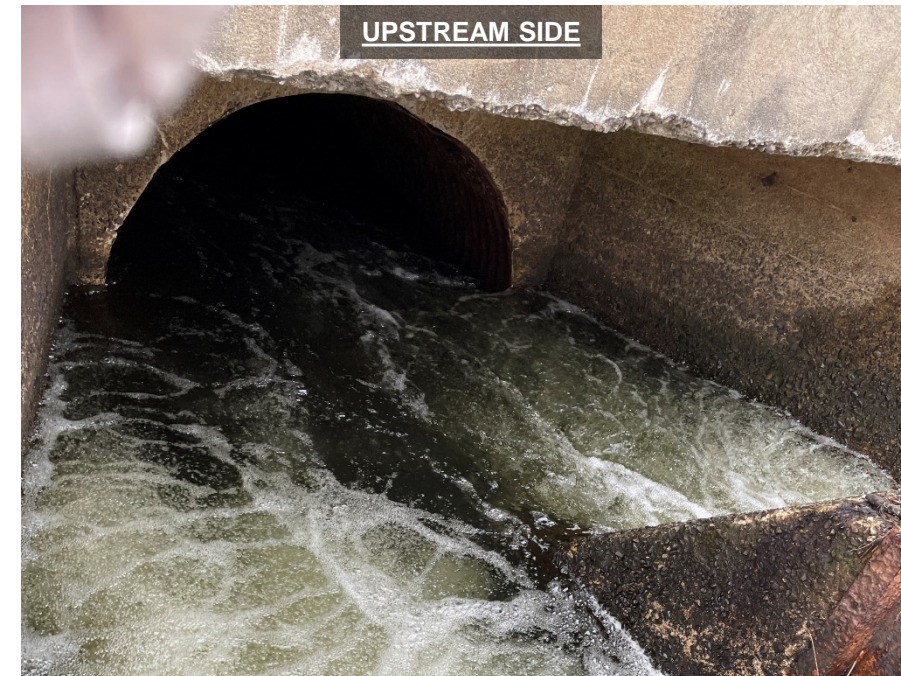
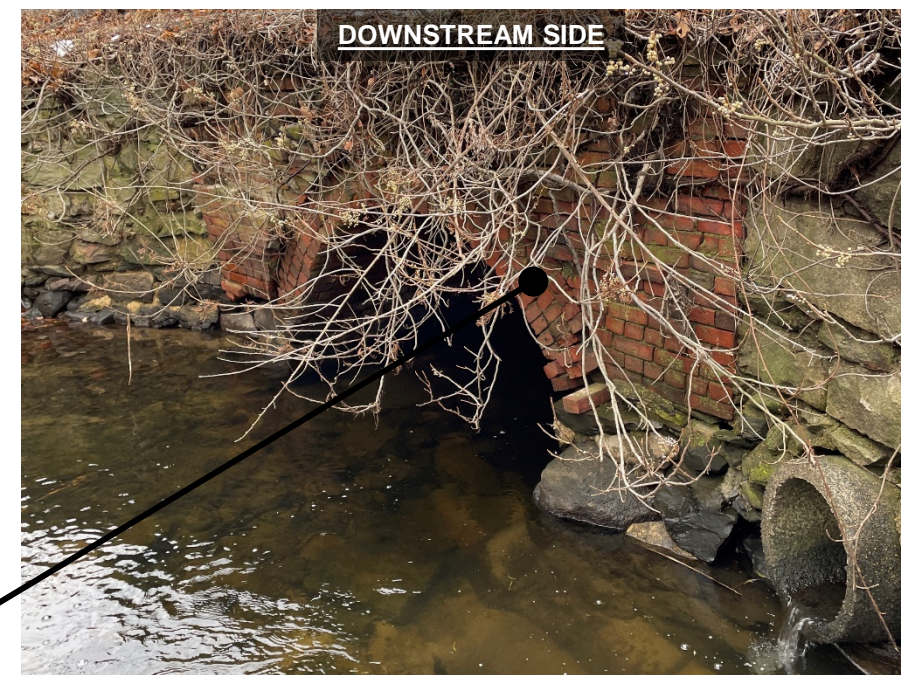
Deteriorating Headwall and Culvert; Undersized Culvert Crossing

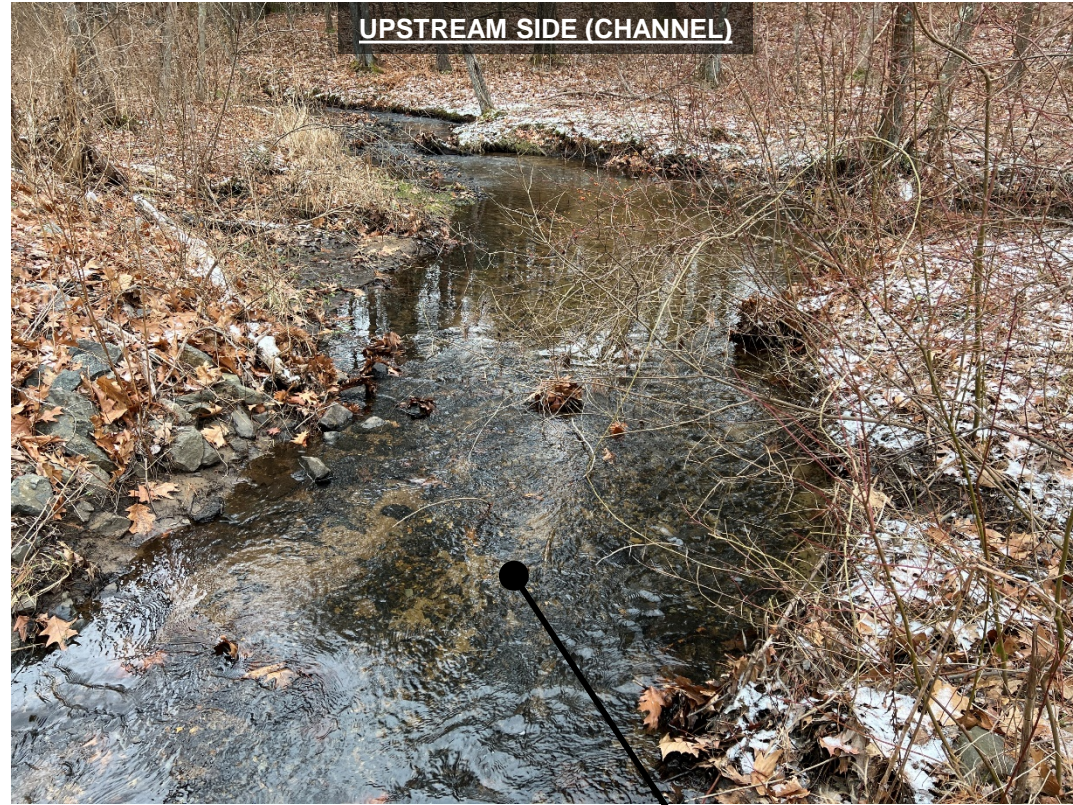
Evidence of  
Sediment  
Deposition
