# Johnson Creek Watershed Flood Resiliency Project

## *Final Report*

Municipal Vulnerability Preparedness (MVP) Program Grant 2021, RFR ENV 22 MVP 02

**Town of Groveland**

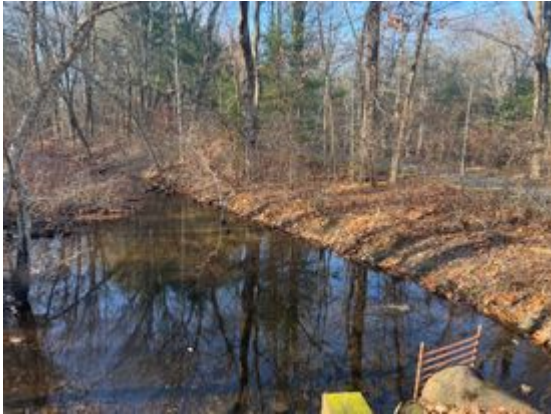
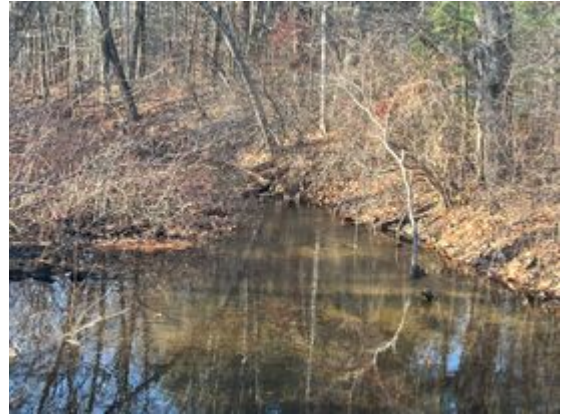
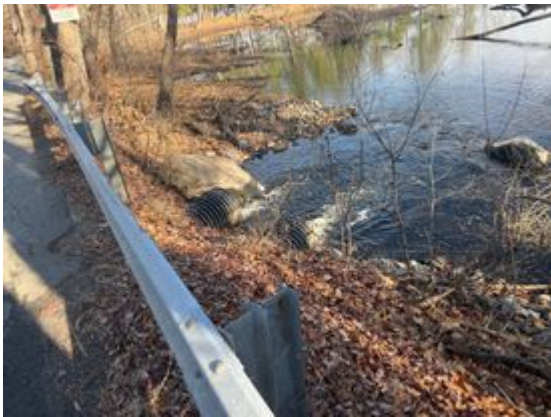
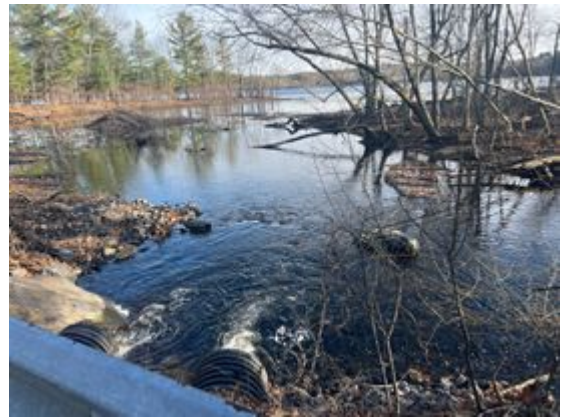
**Photo Log**

<p>USGS The National Map: National Boundaries Dataset, 3DEP Elevatio... Powered by Esri</p>		
Culvert Information (If Applicable)		
<b>Material:</b> Reinforced Concrete (RCP)	<b>Geometry:</b> Circular	<b>Number of Barrels:</b> 2
<b>Height (ft):</b> 2.5	<b>Span (ft):</b> 2.5	<b>Length (ft):</b> 50
<b>Geometry Notes (if any):</b> Same (upstream is CMP, downstream is ADS)		
<b>Condition Observations:</b> Debris / vegetation blockage, Culvert scour, Embankment erosion or instability, Beaver activity		
<b>Overall Condition:</b> Poor		
<i>Comments:</i> Culverts are undersized. They have overtopped onto Lower Center Street once or twice every wet season and periodically from upgradient beaver dams (i.e., private upstream landowner periodically removes beaver dams from unnamed pond near Marbles Lane).

- SC-RC002: Install bioretention basin at Groveland Park.
- RC005: Perform stream continuity improvements at Lowe Center Street (inlet to Johnsons Pond)
- MA01204A: Perform retrofits to Johnsons Pond outlet structure to enable operations to mimic natural floodplain function (i.e., pre-storm releases).

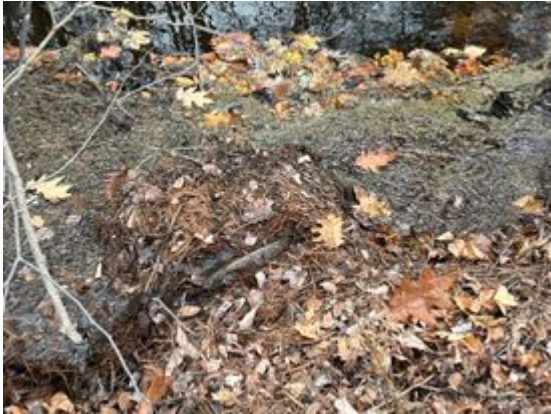
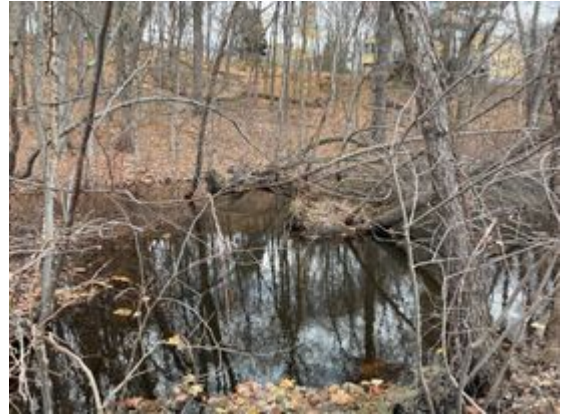
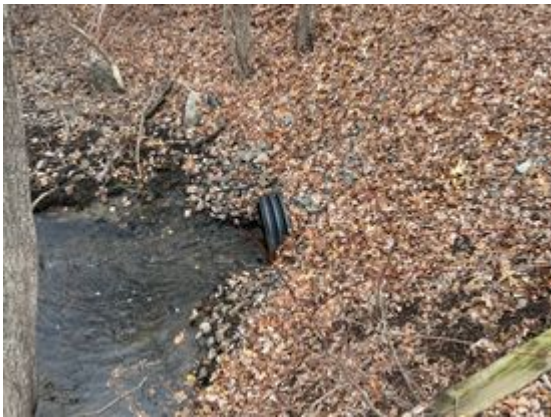
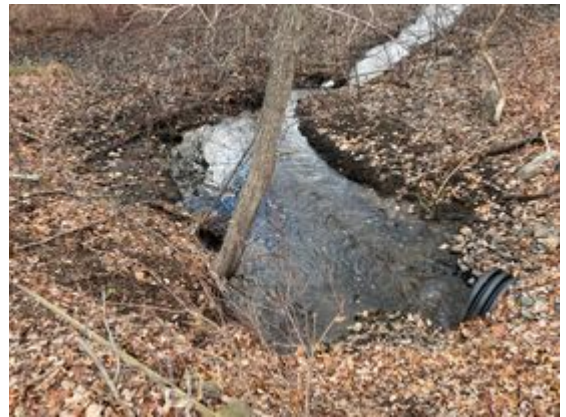
**Photo Log**

<p>USGS The National Map: National Boundaries Dataset, 3DEP Elevatio... Powered by Esri</p>		
Culvert Information (If Applicable)		
<b>Material:</b> High-Density Polyethylene (HDPE)	<b>Geometry:</b> Circular	<b>Number of Barrels:</b> 1
<b>Height (ft):</b> 3	<b>Span (ft):</b> 3	<b>Length (ft):</b> 35
<b>Geometry Notes (if any):</b>		
<b>Condition Observations:</b> Debris / vegetation blockage, Culvert deformed or collapsing, Culvert undermining, Embankment erosion or instability		
<b>Overall Condition:</b> Poor		
<i>Comments:</i> Bottom of CMP is corroding away and culvert is collapsing. Emergency repair performed in 2020 to stub in a piece of HDPE pipe.		
Dam Information (If Applicable)		
<b>Dam Type:</b>	<b>Control Mechanism:</b>	
<b>Control Mechanism Comments (if any):</b>

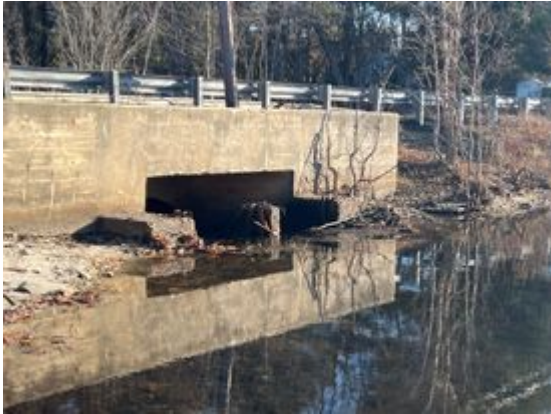
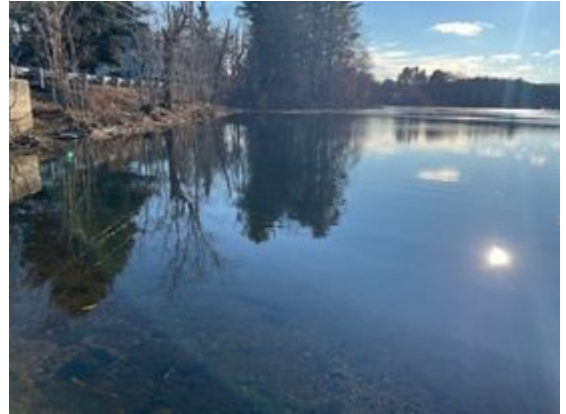
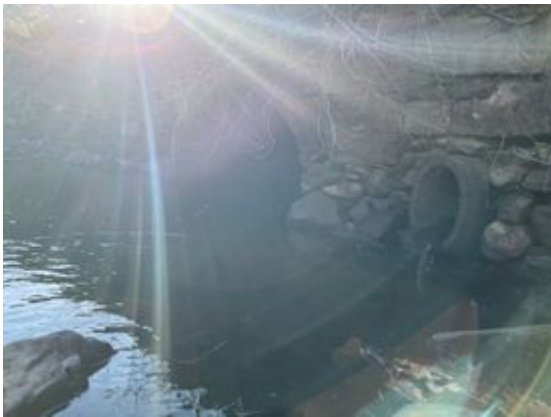
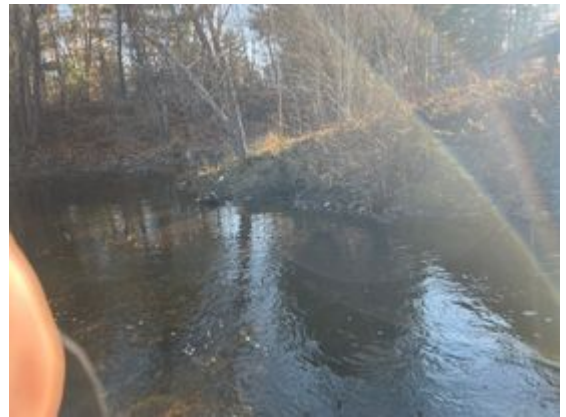
**Photo Log**

<b>Control Configuration Comments (if any):</b>		
<b>Outlet / Spillway Observations:</b> <i>cracking / spalling / corroding concrete, collapsing concrete</i>		
<b>Embankment Observations:</b> <i>woody vegetation (trees/brush)</i>		
<b>Overall Condition:</b> Fair		
<i>Comments:</i> Controls on the inflow side are outdated and limited. Concrete weir is spalling. See inspection form for Culvert (MA01204B) for downstream issues.

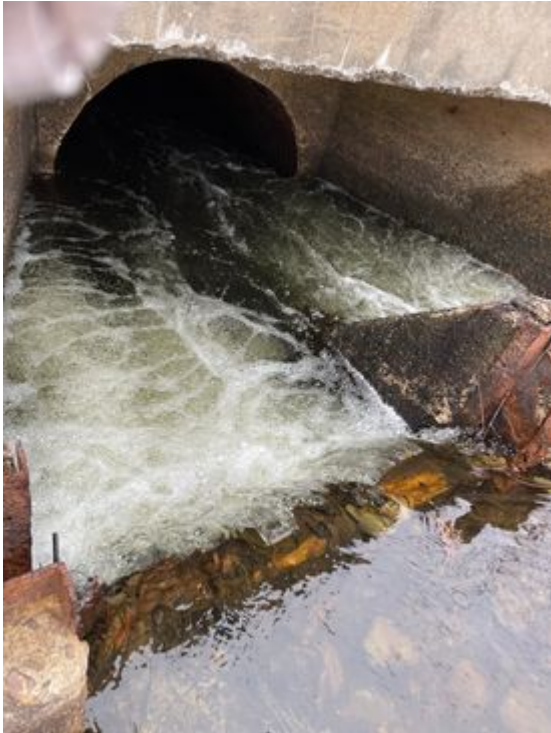
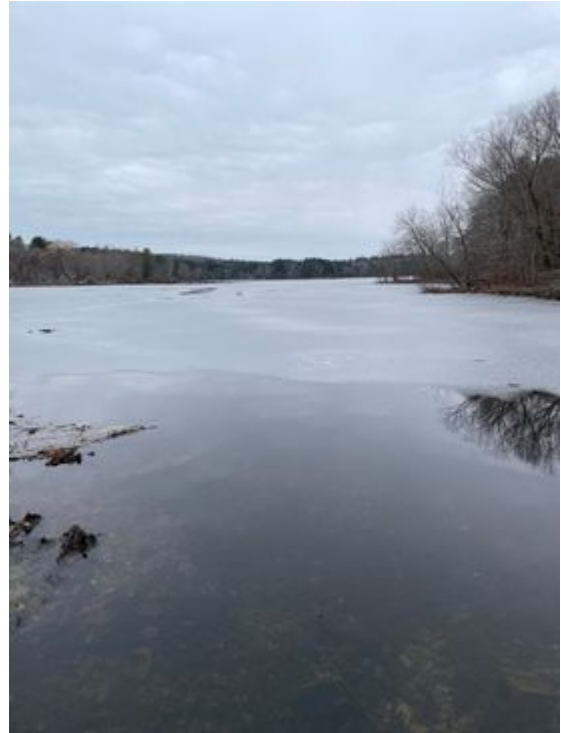
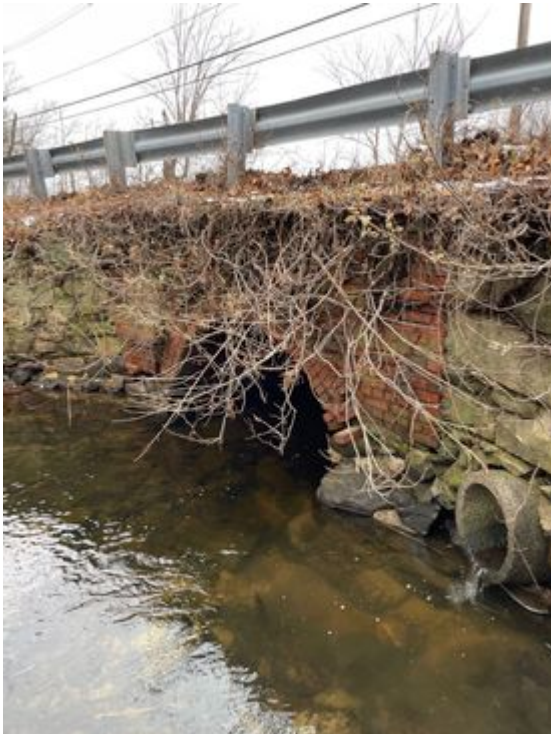
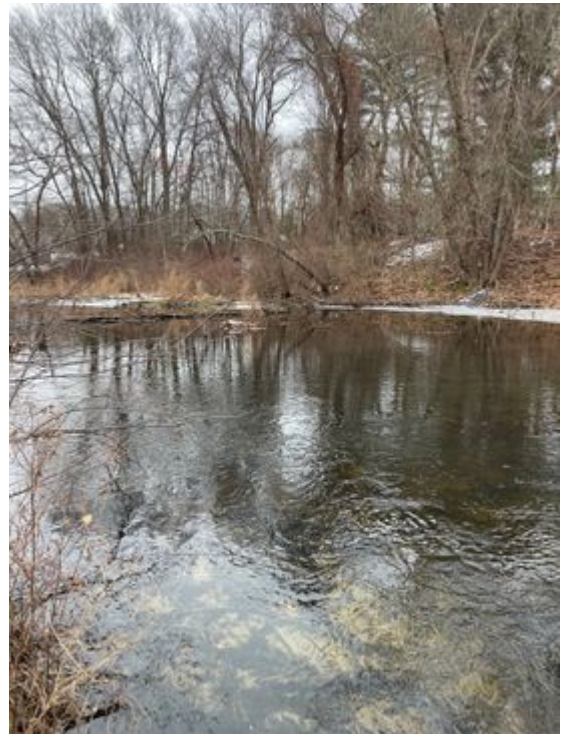
**Photo Log**

<p>USGS The National Map: National Boundaries Dataset, 3DEP Elevatio... Powered by Esri</p>		
Culvert Information (If Applicable)		
<b>Material:</b> Corrugated Metal (CMP)	<b>Geometry:</b> Arched (open bottom)	<b>Number of Barrels:</b> 1
<b>Height (ft):</b> 4	<b>Span (ft):</b> 6	<b>Length (ft):</b> 40
<b>Geometry Notes (if any):</b>		
<b>Condition Observations:</b> Headwall deformed or collapsing		
<b>Overall Condition:</b> Poor		
<i>Comments:</i> Upstream is metal pipe (newer), downstream is brick (50-60 yrs old). Downstream headwall and culvert outlet is starting to fall apart.		
Dam Information (If Applicable)		
<b>Dam Type:</b>	<b>Control Mechanism:</b>	
<b>Control Mechanism Comments (if any):</b>		
<b>Control Configuration Comments (if any):</b>

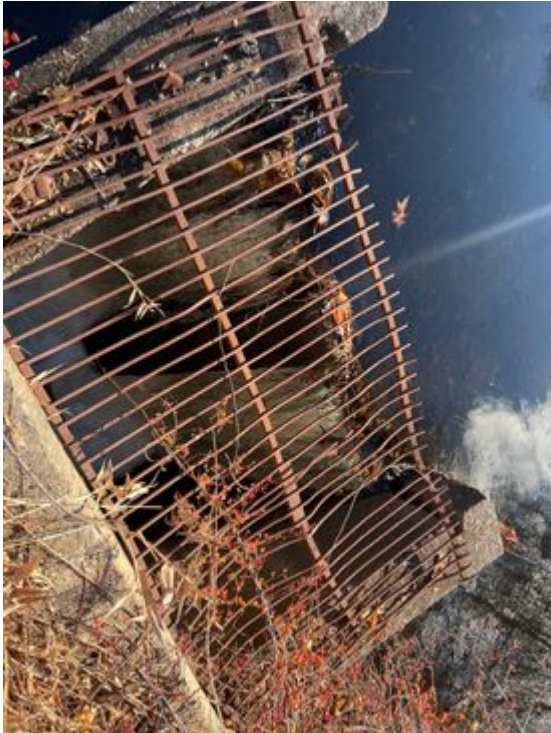
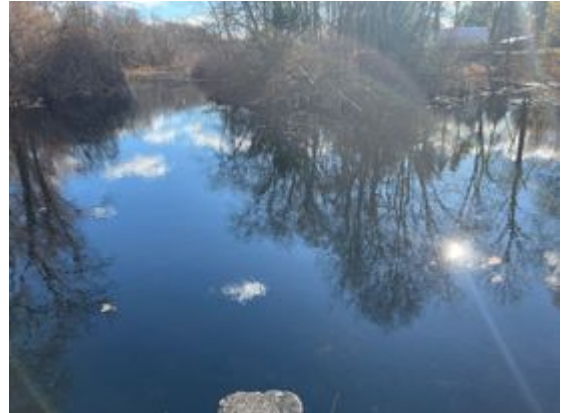
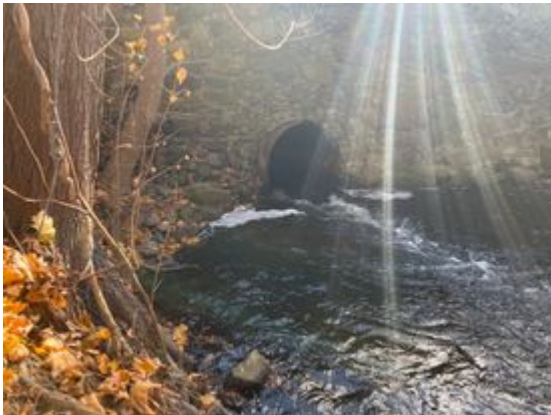
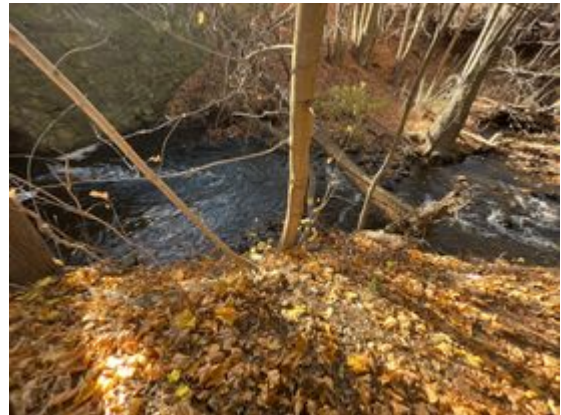
<p>USGS The National Map: National Boundaries Dataset, 3DEP Elevatio... Powered by Esri</p>		
Culvert Information (If Applicable)		
<b>Material:</b>	<b>Geometry:</b>	<b>Number of Barrels:</b>
<b>Height (ft):</b>	<b>Span (ft):</b>	<b>Length (ft):</b>
<b>Geometry Notes (if any):</b>		
<b>Condition Observations:</b>		
<b>Overall Condition:</b>		
<i>Comments:</i>		
Dam Information (If Applicable)		
<b>Dam Type:</b> Masonry Dam	<b>Control Mechanism:</b> Stoplogs / Flashboards	
<b>Control Mechanism Comments (if any):</b>		
<b>Control Configuration Comments (if any):</b>		
<b>Outlet / Spillway Observations:</b> debris / blockage		
<b>Embankment Observations:</b> no observed issues		
<b>Overall Condition:</b> Fair		
<i>Comments:</i> Embankment appears to be in good condition. Concrete outflow weir with flashboards appears to be in good condition. Grate above weir is deformed.

<b>Geometry:</b> Standing Water (i.e., Pond)	<b>Material:</b> Vegetated / Natural
<b>Appx. Bankfull Width (ft):</b>	<b>Sedimentation Level:</b> No observed sedimentation
<p><b>Condition Observations</b> overgrown vegetation, debris / blockage, evidence of previous overtopping onto floodplain, beaver activity  <i>Comments:</i> Dam overflow weir grates are susceptible to clogging. Periodic maintenance is required to inspect and remove debris to avoid flood risk from clogging.</p>	
<b>Downstream Channel Information</b>	
<b>Geometry:</b> Irregular	<b>Material:</b> Vegetated / Natural
<b>Appx. Bankfull Width (ft):</b> 25	<b>Sedimentation Level:</b> No observed sedimentation
<p><b>Condition Observations</b> channel erosion, bank erosion/undermining, overgrown vegetation, debris / blockage, evidence of previous overtopping onto floodplain  <i>Comments:</i> Undermined trees and bank undercutting observed in downstream channel. Potential candidate for bank stabilization.</p>

<b>General Recommendations (based on initial findings)</b>	
Stabilize downstream channel and remove fallen debris (trees). Address failing CMP culvert at outflow (i.e., no bottom) (see inspection form MA00188B).

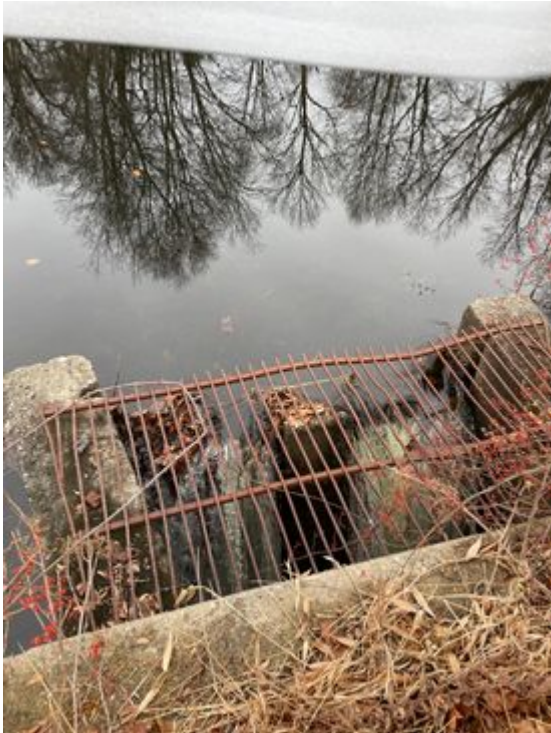
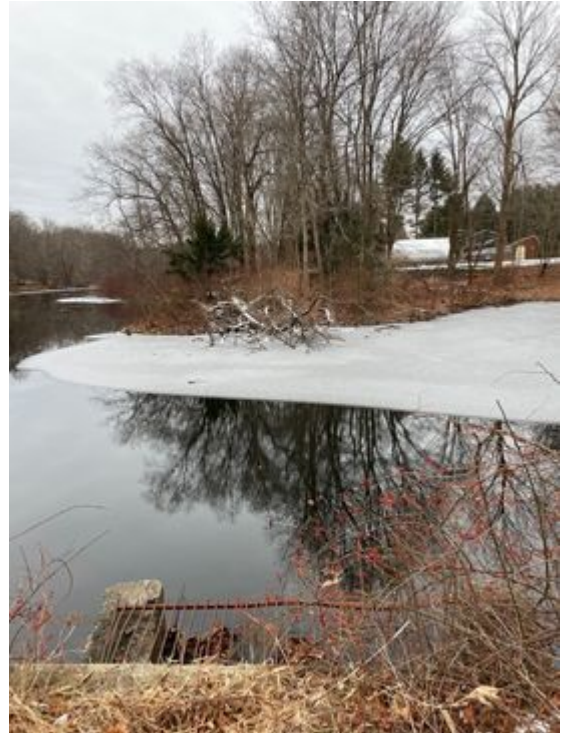
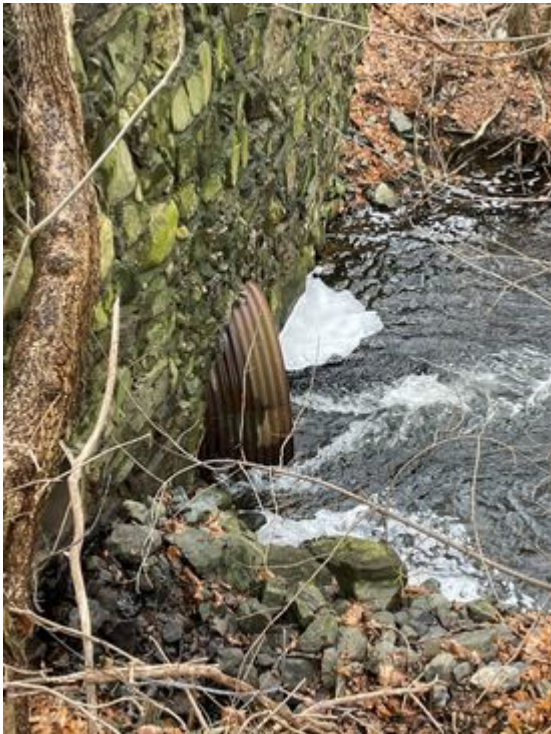
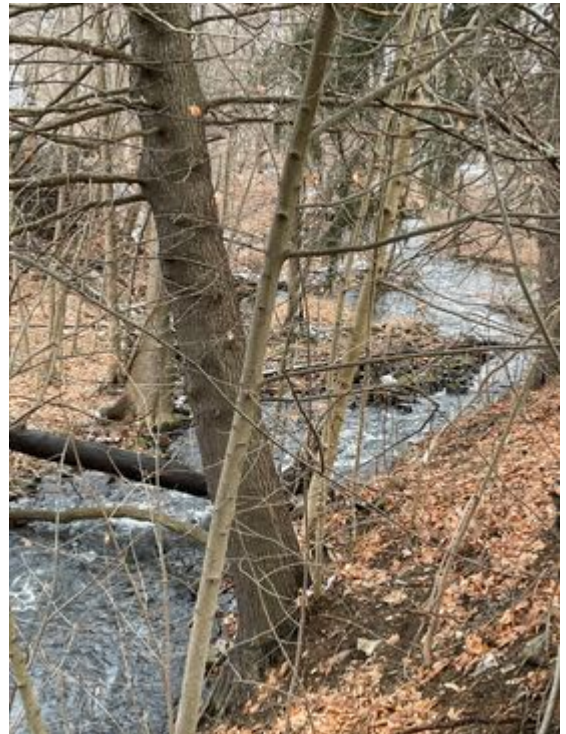
<b>Upstream Channel Information</b>	
<b>Geometry:</b> Standing Water (i.e., Pond)	<b>Material:</b> Vegetated / Natural
<b>Appx. Bankfull Width (ft):</b>	<b>Sedimentation Level:</b> No observed sedimentation
<b>Condition Observations</b> debris / blockage <i>Comments:</i> Debris starting to pile up in front of culvert inlet.	
<b>Downstream Channel Information</b>	
<b>Geometry:</b> Irregular	<b>Material:</b> Vegetated / Natural
<b>Appx. Bankfull Width (ft):</b>	<b>Sedimentation Level:</b> No observed sedimentation
<b>Condition Observations</b> bank erosion/undermining <i>Comments:</i> See inspection form for MA00188A.	
<b>General Recommendations (based on initial findings)</b>	
Address failing CMP culvert at outflow (i.e., no bottom). Fix undermining foundation footing out outflow headwall. Could lead to overall instability of the dam over time. See MA00188A for recommendations for downstream channel.

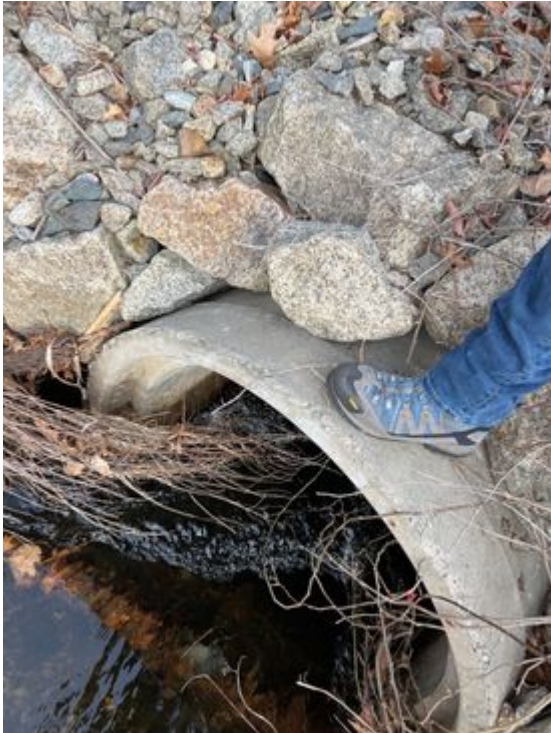
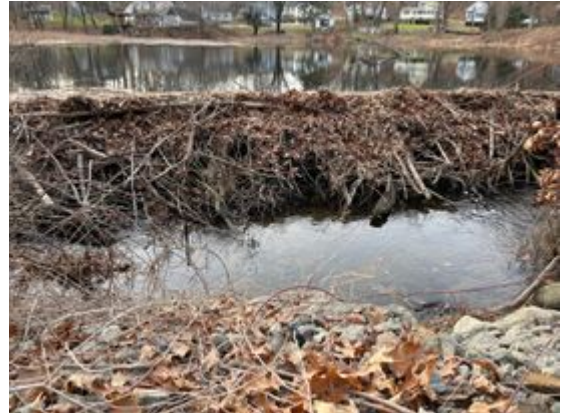
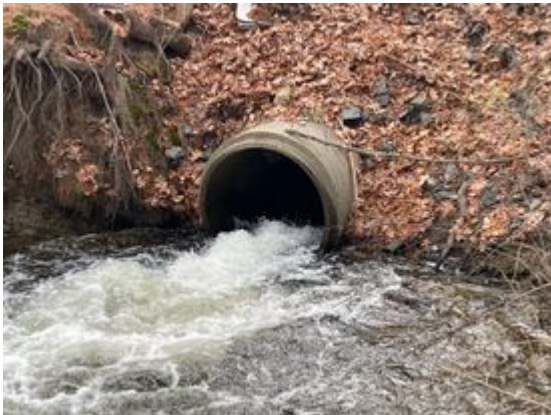
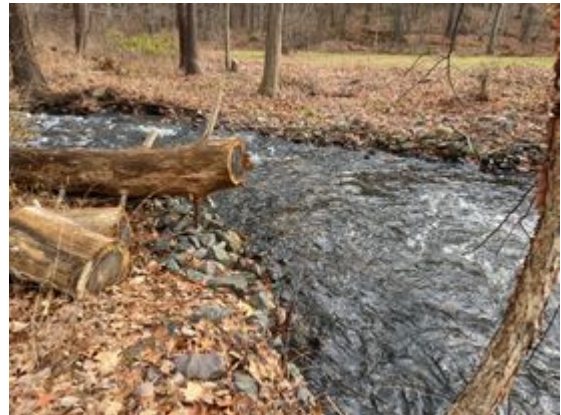
<b>Overall Condition:</b> Fair		
<i>Comments:</i> Previous 60" steep pipe was repaired years ago with upgradient and downgradient RCP – a section of steel pipe still remains in the center. One of the repair joints appears to be failing and is causing a depression in the road.		
Dam Information (If Applicable)		
<b>Dam Type:</b>	<b>Control Mechanism:</b>	
<b>Control Mechanism Comments (if any):</b>		
<b>Control Configuration Comments (if any):</b>		
<b>Outlet / Spillway Observations:</b>		
<b>Embankment Observations:</b>

<b>Overall Condition:</b> <i>Comments:</i>	
<b>Upstream Channel Information</b>	
<b>Geometry:</b> Standing Water (i.e., Pond)	<b>Material:</b> Vegetated / Natural
<b>Appx. Bankfull Width (ft):</b>	<b>Sedimentation Level:</b> 10-25%
<b>Condition Observations</b> overgrown vegetation, debris / blockage, beaver activity <i>Comments:</i> Large upstream beaver dam is completely blocking the outflow. Has been in place for many years.	
<b>Downstream Channel Information</b>	
<b>Geometry:</b> Irregular	<b>Material:</b> Riprap
<b>Appx. Bankfull Width (ft):</b> 20	<b>Sedimentation Level:</b> < 10%
<b>Condition Observations</b> sedimentation, channel erosion, bank erosion/undermining, overgrown vegetation, debris / blockage, evidence of previous overtopping onto floodplain, beaver activity <i>Comments:</i>	
<b>General Recommendations (based on initial findings)</b>	
Replace failing pipe. Address beaver issues at the inflow.

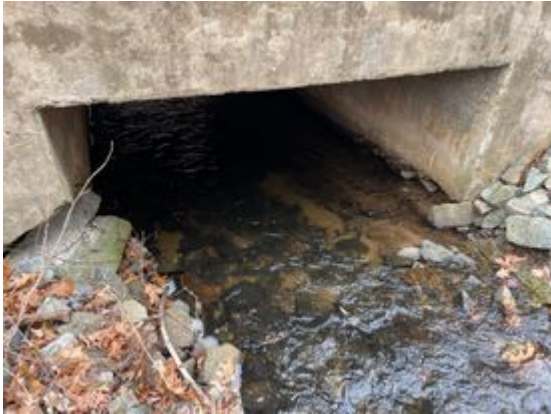
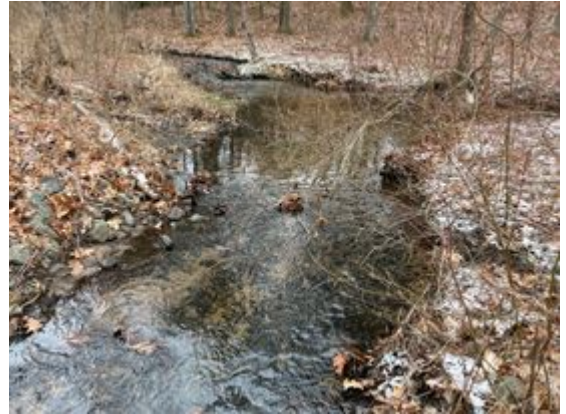
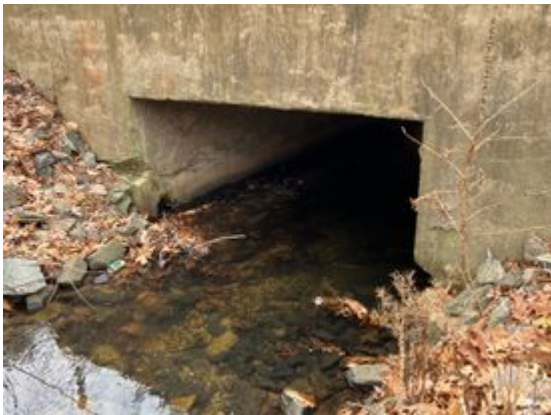
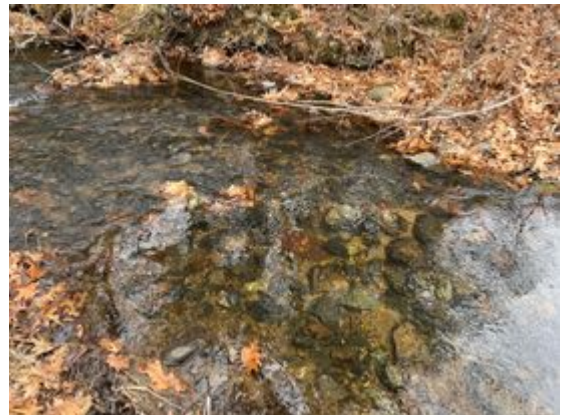
<b>Upstream Channel Information</b>	
<b>Geometry:</b> Irregular	<b>Material:</b> Vegetated / Natural
<b>Appx. Bankfull Width (ft):</b> 7	<b>Sedimentation Level:</b> 10-25%
<b>Condition Observations</b> sedimentation, channel erosion, bank erosion/undermining <i>Comments:</i>	
<b>Downstream Channel Information</b>	
<b>Geometry:</b> Irregular	<b>Material:</b> Riprap
<b>Appx. Bankfull Width (ft):</b> 8	<b>Sedimentation Level:</b> 10-25%
<b>Condition Observations</b> sedimentation, channel erosion, bank erosion/undermining, overgrown vegetation, debris / blockage <i>Comments:</i>	
<b>General Recommendations (based on initial findings)</b>	
This aging culvert has been patched and reworked. Many observed issues (i.e., undermining, scour, exposed footings). Needs to be considered for replacement.

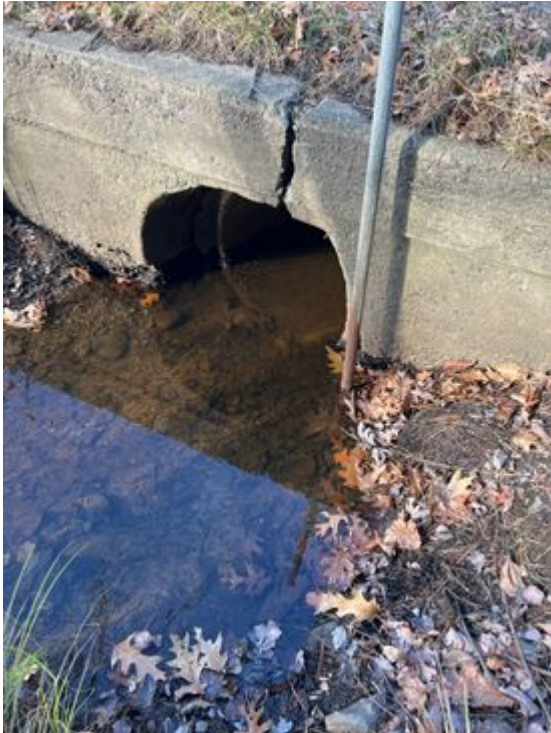
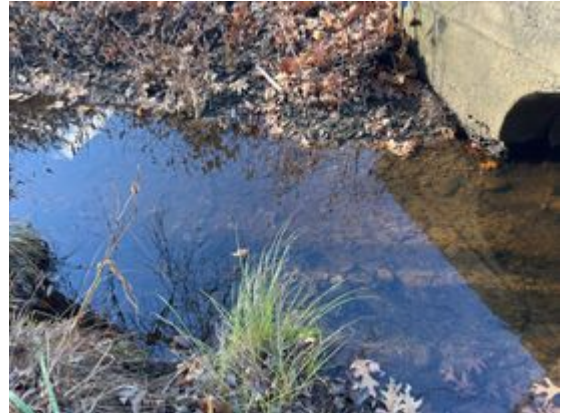
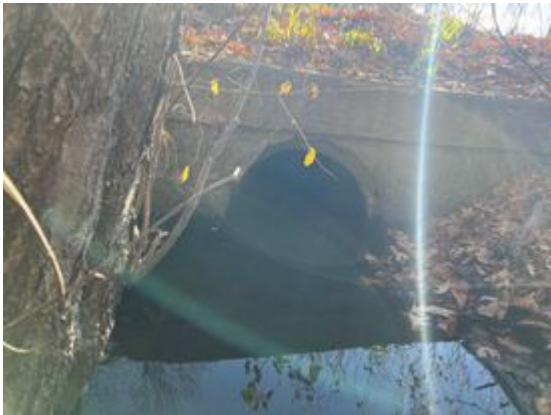
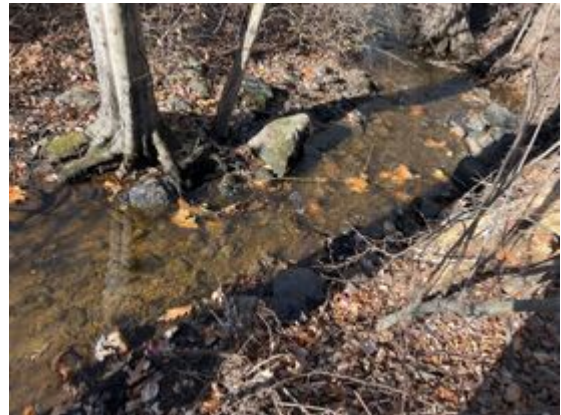
<p>USGS The National Map: National Boundaries Dataset, 3DEP Elevatio... Powered by Esri</p>		
Culvert Information (If Applicable)		
<b>Material:</b> Reinforced Concrete (RCP)	<b>Geometry:</b> Circular	<b>Number of Barrels:</b> 1
<b>Height (ft):</b> 3	<b>Span (ft):</b> 3	<b>Length (ft):</b> 40
<b>Geometry Notes (if any):</b>		
<b>Condition Observations:</b> Culvert lining cracking, spalling, corroding, Culvert scour, Evidence of previous surcharging, Headwall cracking, spalling, corroding, Headwall deformed or collapsing, Beaver activity		
<b>Overall Condition:</b> Fair		
<i>Comments:</i> Upstream and downstream headwall is cracking. Culvert appears to be corroding.		
Dam Information (If Applicable)		
<b>Dam Type:</b>	<b>Control Mechanism:</b>

<b>Upstream Channel Information</b>	
<b>Geometry:</b> Rectangular	<b>Material:</b> Vegetated / Natural
<b>Appx. Bankfull Width (ft):</b> 5	<b>Sedimentation Level:</b> 10-25%
<p><b>Condition Observations</b> sedimentation, channel erosion, overgrown vegetation, evidence of previous overtopping onto floodplain, beaver activity  <i>Comments:</i> Beaver activity makes it very difficult to address issues</p>	
<b>Downstream Channel Information</b>	
<b>Geometry:</b> Irregular	<b>Material:</b> Vegetated / Natural
<b>Appx. Bankfull Width (ft):</b> 5	<b>Sedimentation Level:</b> 10-25%
<p><b>Condition Observations</b> sedimentation, channel erosion, evidence of previous overtopping onto floodplain, beaver activity  <i>Comments:</i></p>	
<b>General Recommendations (based on initial findings)</b>	
Replace collapsing headwalls. Repair or replace culvert.

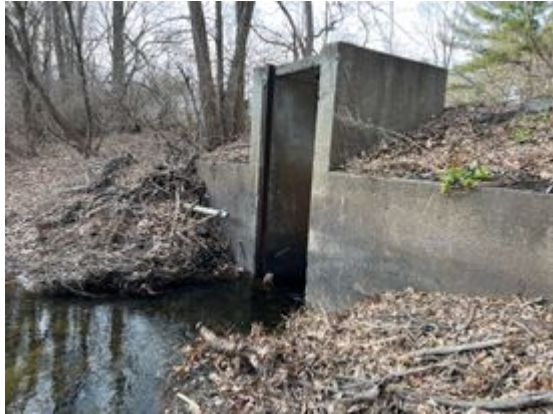
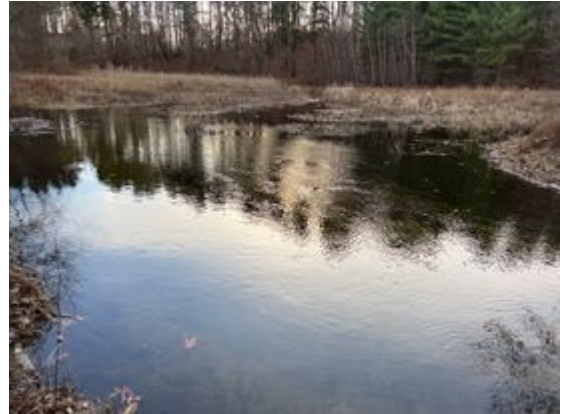
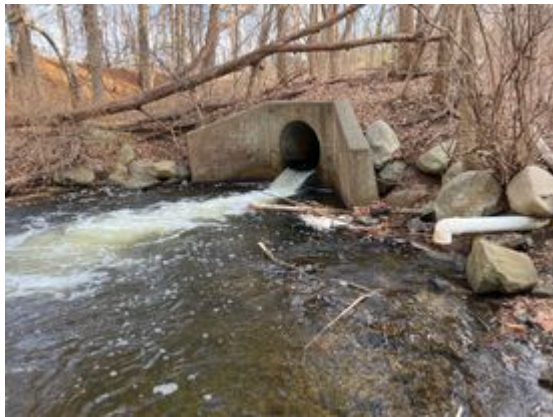
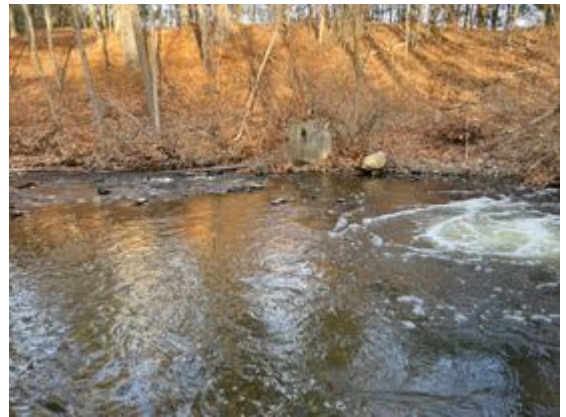
<b>Control Configuration Comments (if any):</b>		
<b>Outlet / Spillway Observations:</b> cracking / spalling / corroding concrete		
<b>Embankment Observations:</b> sinkholes, animal burrows		
<b>Overall Condition:</b> Fair		
<i>Comments:</i> Concrete at outlet control structure is spalling. Undermining observed at outlet structure.

Sinkhole observed in dam embankment that is several feet deep.	
<b>Upstream Channel Information</b>	
<b>Geometry:</b> Irregular	<b>Material:</b> Vegetated / Natural
<b>Appx. Bankfull Width (ft):</b>	<b>Sedimentation Level:</b> < 10%
<b>Condition Observations</b> no observed issues <i>Comments:</i>	
<b>Downstream Channel Information</b>	
<b>Geometry:</b> Irregular	<b>Material:</b> Riprap
<b>Appx. Bankfull Width (ft):</b> 40	<b>Sedimentation Level:</b> 10-25%
<b>Condition Observations</b> channel erosion, bank erosion/undermining <i>Comments:</i>	
<b>General Recommendations (based on initial findings)</b>	
Inspect and repair sinkhole observed on dam embankment.

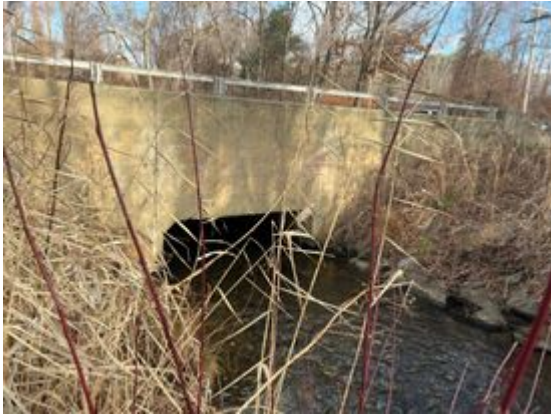
**Photo 1: Upstream Photo of Culvert / Dam**

<p>USGS The National Map: National Boundaries Dataset, 3DEP Elevatio... Powered by Esri</p>		
Culvert Information (If Applicable)		
<b>Material:</b> Reinforced Concrete (RCP)	<b>Geometry:</b> Box	<b>Number of Barrels:</b> Newer style Box culvert
<b>Height (ft):</b> 3	<b>Span (ft):</b> 8	<b>Length (ft):</b> 35
<b>Geometry Notes (if any):</b> NA		
<b>Condition Observations:</b> no observed issues, Culvert scour		
<b>Overall Condition:</b> Good <i>Comments:</i> This is a newer box culvert		
Dam Information (If Applicable)		
<b>Dam Type:</b>	<b>Control Mechanism:</b>	
<b>Control Mechanism Comments (if any):</b>		
<b>Control Configuration Comments (if any):</b>		
<b>Outlet / Spillway Observations:</b>		
<b>Embankment Observations:</b>

<b>Geometry:</b> Rectangular	<b>Material:</b> Vegetated / Natural
<b>Appx. Bankfull Width (ft):</b> 12	<b>Sedimentation Level:</b> 10-25%
<p><b>Condition Observations</b> sedimentation, channel erosion, bank erosion/undermining, overgrown vegetation, evidence of previous overtopping onto floodplain  <i>Comments:</i> Severe bank erosion of upstream channel. Debris frequently piles up at this confluence point.</p>	
<b>Downstream Channel Information</b>	
<b>Geometry:</b> Rectangular	<b>Material:</b> Vegetated / Natural
<b>Appx. Bankfull Width (ft):</b> 12	<b>Sedimentation Level:</b> 10-25%
<p><b>Condition Observations</b> no observed issues  <i>Comments:</i> No apparent issues.</p>	
<b>General Recommendations (based on initial findings)</b>	
Streambank stabilization recommended.

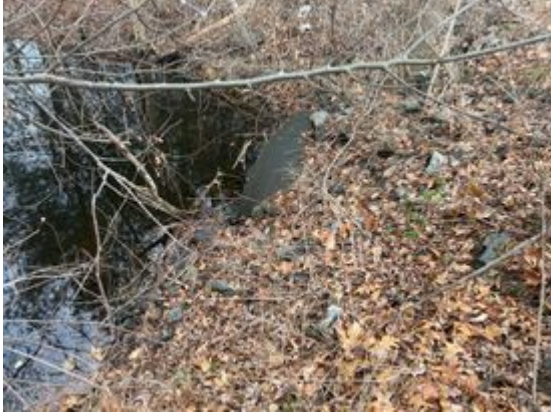
**Photo 1: Upstream Photo of Culvert / Dam**

<p>USGS The National Map: National Boundaries Dataset, 3DEP Elevatio... Powered by Esri</p>		
Culvert Information (If Applicable)		
<b>Material:</b> Masonry Block	<b>Geometry:</b> Box	<b>Number of Barrels:</b> 1
<b>Height (ft):</b> 6	<b>Span (ft):</b> 8	<b>Length (ft):</b> 40
<b>Geometry Notes (if any):</b>		
<b>Condition Observations:</b> no observed issues		
<b>Overall Condition:</b> Good		
<i>Comments:</i> Access to culvert is challenging. Culvert is aging, but does not have any apparent issues.		
Dam Information (If Applicable)		
<b>Dam Type:</b>	<b>Control Mechanism:</b>	
<b>Control Mechanism Comments (if any):</b>		
<b>Control Configuration Comments (if any):</b>		
<b>Outlet / Spillway Observations:</b>		
<b>Embankment Observations:</b>

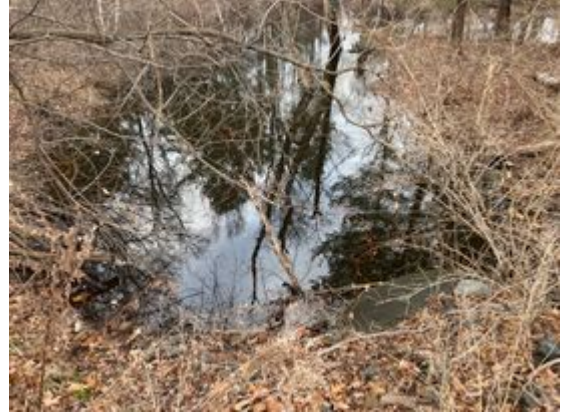
**Photo 2: Upstream Channel**

<b>Geometry:</b> Irregular	<b>Material:</b> Vegetated / Natural
<b>Appx. Bankfull Width (ft):</b>	<b>Sedimentation Level:</b> No observed sedimentation
<b>Condition Observations</b> debris / blockage <i>Comments:</i> Upstream channel frequently receives debris from storms.	
<b>Downstream Channel Information</b>	
<b>Geometry:</b> Irregular	<b>Material:</b> Vegetated / Natural
<b>Appx. Bankfull Width (ft):</b>	<b>Sedimentation Level:</b> No observed sedimentation
<b>Condition Observations</b> no observed issues <i>Comments:</i>	
<b>General Recommendations (based on initial findings)</b>	
Monitor for upgradient debris blockages.

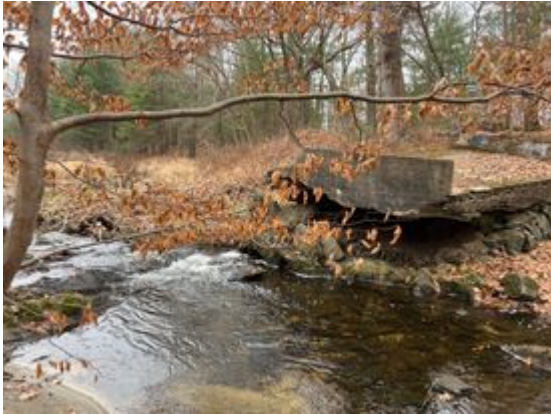
**Photo 1: Upstream Photo of Culvert / Dam**

<p>USGS The National Map: National Boundaries Dataset, 3DEP Elevatio... Powered by Esri</p>		
Culvert Information (If Applicable)		
<b>Material:</b>	<b>Geometry:</b>	<b>Number of Barrels:</b>
<b>Height (ft):</b>	<b>Span (ft):</b>	<b>Length (ft):</b>
<b>Geometry Notes (if any):</b>		
<b>Condition Observations:</b>		
<b>Overall Condition:</b>		
<i>Comments:</i>		
Dam Information (If Applicable)		
<b>Dam Type:</b> Masonry Dam	<b>Control Mechanism:</b> No Control Mechanism	
<b>Control Mechanism Comments (if any):</b>		
<b>Control Configuration Comments (if any):</b> Box style built by stones		
<b>Outlet / Spillway Observations:</b> debris / blockage, collapsing concrete		
<b>Embankment Observations:</b> evidence of previous overtopping, sinkholes, animal burrows, erosion, poor abutment contact

<b>Overall Condition:</b> Good		
<i>Comments:</i> Condition is "N/A". This damn collapsed and fell apart almost 20 years ago.		
Upstream Channel Information		
<b>Geometry:</b> Irregular	<b>Material:</b> Vegetated / Natural

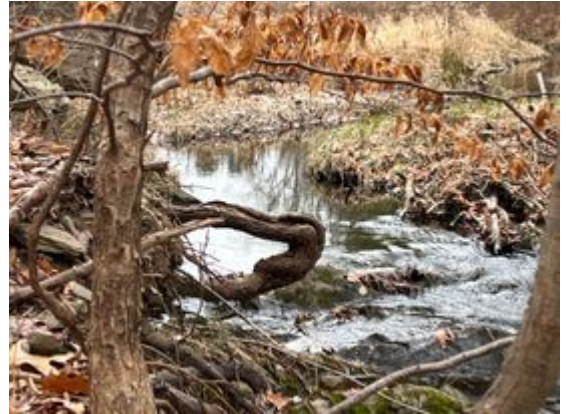
**Photo 2: Upstream Channel**

<b>Appx. Bankfull Width (ft):</b>	<b>Sedimentation Level:</b> < 10%
<b>Condition Observations</b> channel erosion, overgrown vegetation, debris / blockage <i>Comments:</i> Beavers have in a day to this area and created their own ponds upstream	
<b>Downstream Channel Information</b>	
<b>Geometry:</b> Irregular	<b>Material:</b> Vegetated / Natural
<b>Appx. Bankfull Width (ft):</b>	<b>Sedimentation Level:</b> < 10%
<b>Condition Observations</b> bank erosion/undermining, overgrown vegetation, evidence of previous overtopping onto floodplain <i>Comments:</i>	
<b>General Recommendations (based on initial findings)</b>

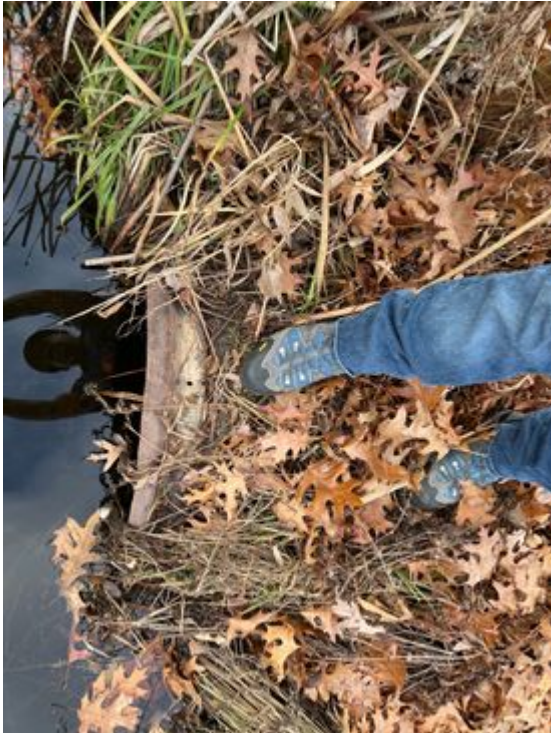
**Photo 1: Upstream Photo of Culvert / Dam**

<p>USGS The National Map: National Boundaries Dataset, 3DEP Elevatio... Powered by Esri</p>		
Culvert Information (If Applicable)		
<b>Material:</b> Corrugated Metal (CMP)	<b>Geometry:</b> Circular	<b>Number of Barrels:</b> 1
<b>Height (ft):</b> 3	<b>Span (ft):</b> 3	<b>Length (ft):</b> 35
<b>Geometry Notes (if any):</b>		
<b>Condition Observations:</b> Debris / vegetation blockage, Culvert deformed or collapsing, Evidence of previous surcharging, Embankment erosion or instability		
<b>Overall Condition:</b> Poor		
<i>Comments:</i> Culvert was almost full with standing water at time of inspection and may be partially blocked. Appears to be collapsing or deforming.		
Dam Information (If Applicable)		
<b>Dam Type:</b>	<b>Control Mechanism:</b>

<b>Upstream Channel Information</b>	
<b>Geometry:</b> Irregular	<b>Material:</b> Vegetated / Natural
<b>Appx. Bankfull Width (ft):</b> 10	<b>Sedimentation Level:</b> No observed sedimentation
<b>Condition Observations</b> bank erosion/undermining, overgrown vegetation <i>Comments:</i>	
<b>Downstream Channel Information</b>	
<b>Geometry:</b> Irregular	<b>Material:</b> Vegetated / Natural
<b>Appx. Bankfull Width (ft):</b> 13	<b>Sedimentation Level:</b> No observed sedimentation
<b>Condition Observations</b> no observed issues <i>Comments:</i>	
<b>General Recommendations (based on initial findings)</b>	
Replace failing culvert. Reconfigure installation elevations to enable passage of water.

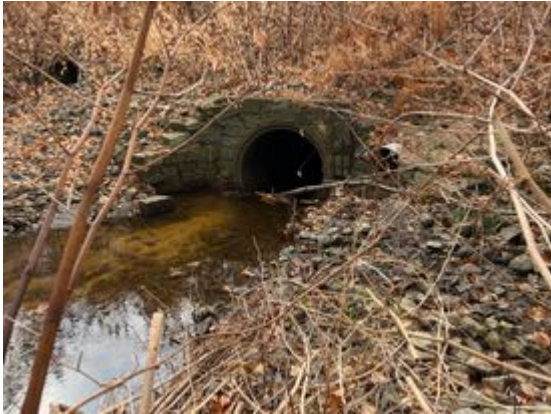
**Photo 1: Upstream Photo of Culvert / Dam**

<p>USGS The National Map: National Boundaries Dataset, 3DEP Elevatio... Powered by Esri</p>		
Culvert Information (If Applicable)		
<b>Material:</b> Reinforced Concrete (RCP)	<b>Geometry:</b> Circular	<b>Number of Barrels:</b> 1
<b>Height (ft):</b> 4	<b>Span (ft):</b> 4	<b>Length (ft):</b> 65
<b>Geometry Notes (if any):</b>		
<b>Condition Observations:</b> no observed issues, Perched culvert		
<b>Overall Condition:</b> Good		
<i>Comments:</i>		
Dam Information (If Applicable)		
<b>Dam Type:</b>	<b>Control Mechanism:</b>	
<b>Control Mechanism Comments (if any):</b>		
<b>Control Configuration Comments (if any):</b>		
<b>Outlet / Spillway Observations:</b>		
<b>Embankment Observations:</b>		
<b>Overall Condition:</b>		
<i>Comments:</i>		
Upstream Channel Information

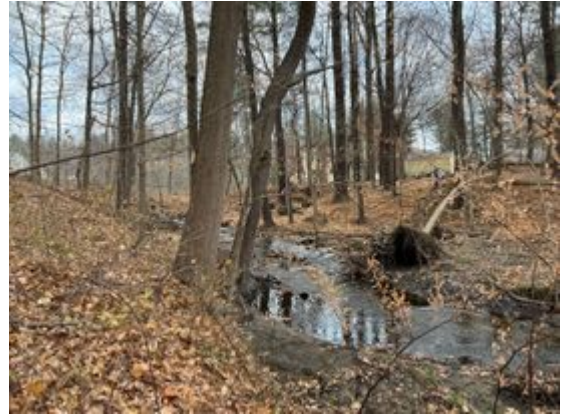
**Photo 2: Upstream Channel**

<b>Geometry:</b> Irregular	<b>Material:</b> Vegetated / Natural
<b>Appx. Bankfull Width (ft):</b> 5	<b>Sedimentation Level:</b> 10-25%
<p><b>Condition Observations</b> sedimentation, channel erosion, overgrown vegetation, debris / blockage, evidence of previous overtopping onto floodplain  <i>Comments:</i></p>	
<b>Downstream Channel Information</b>	
<b>Geometry:</b> Irregular	<b>Material:</b> Riprap
<b>Appx. Bankfull Width (ft):</b> 8	<b>Sedimentation Level:</b> No observed sedimentation
<p><b>Condition Observations</b> no observed issues  <i>Comments:</i></p>	
<b>General Recommendations (based on initial findings)</b>	
<p>Upstream channel showed signs of bank erosion and instability (i.e., toppled tree) and sedimentation at the culvert inlet. Potential recommendation to stabilize/restore upstream channel. Explore opportunities at the upgradient Bagnall School to limit the amount of runoff to the channel.</p>

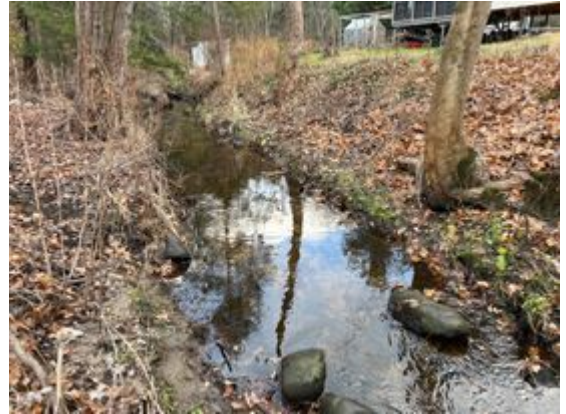
**Photo 2: Upstream Channel**

<b>Geometry:</b> Irregular	<b>Material:</b> Vegetated / Natural
<b>Appx. Bankfull Width (ft):</b> 5	<b>Sedimentation Level:</b> No observed sedimentation
<b>Condition Observations</b> overgrown vegetation, debris / blockage <i>Comments:</i> Channel frequently impacted by debris.	
<b>Downstream Channel Information</b>	
<b>Geometry:</b> Irregular	<b>Material:</b> Vegetated / Natural
<b>Appx. Bankfull Width (ft):</b>	<b>Sedimentation Level:</b> No observed sedimentation
<b>Condition Observations</b> channel erosion <i>Comments:</i>	
<b>General Recommendations (based on initial findings)</b>	
Maintain debris in upgradient channel.

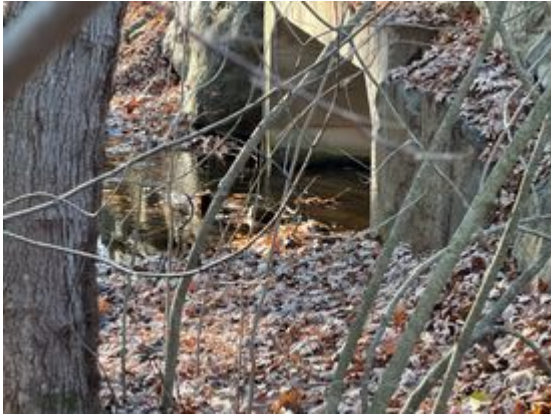
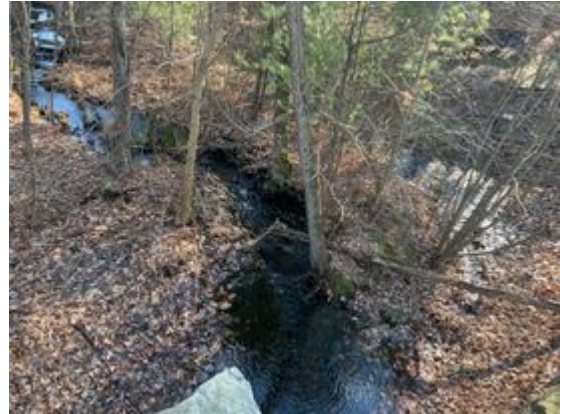
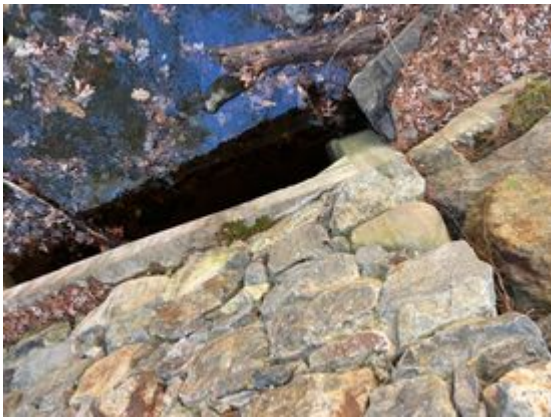
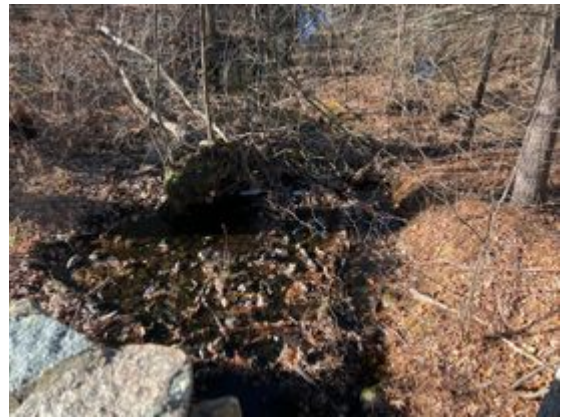
General Information		
<b>Site ID:</b> RC013	<b>Street:</b> Stonebridge Rd	
<b>Inspection Date:</b> December 7, 2021	<b>Site Type:</b> Culvert	
<b>Location Map:</b>		
<p>USGS The National Map: National Boundaries Dataset, 3DEP Elevatio... Powered by Esri</p>		
Culvert Information (If Applicable)		
<b>Material:</b> Reinforced Concrete (RCP)	<b>Geometry:</b> Box	<b>Number of Barrels:</b> 1
<b>Height (ft):</b> 3	<b>Span (ft):</b> 10	<b>Length (ft):</b> 40
<b>Geometry Notes (if any):</b>		
<b>Condition Observations:</b> no observed issues		
<b>Overall Condition:</b> Good		
<i>Comments:</i>		
Dam Information (If Applicable)		
<b>Dam Type:</b>	<b>Control Mechanism:</b>	
<b>Control Mechanism Comments (if any):</b>		
<b>Control Configuration Comments (if any):</b>		
<b>Outlet / Spillway Observations:</b>		
<b>Embankment Observations:</b>		
<b>Overall Condition:</b>		
<i>Comments:</i>		
Upstream Channel Information

<b>Geometry:</b> Irregular	<b>Material:</b> Vegetated / Natural
<b>Appx. Bankfull Width (ft):</b>	<b>Sedimentation Level:</b> No observed sedimentation
<b>Condition Observations</b> no observed issues <i>Comments:</i>	
<b>Downstream Channel Information</b>	
<b>Geometry:</b> Irregular	<b>Material:</b> Vegetated / Natural
<b>Appx. Bankfull Width (ft):</b>	<b>Sedimentation Level:</b> No observed sedimentation
<b>Condition Observations</b> no observed issues, bank erosion/undermining, debris / blockage <i>Comments:</i>	
<b>General Recommendations (based on initial findings)</b>	
Remove debris blockage (ie, tree) from downstream channel. Stabilize channel to prevent future blockage.

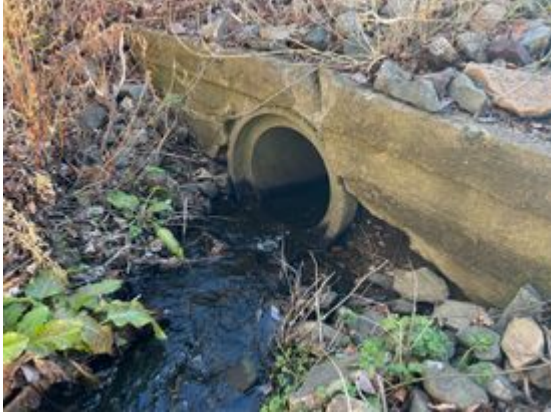
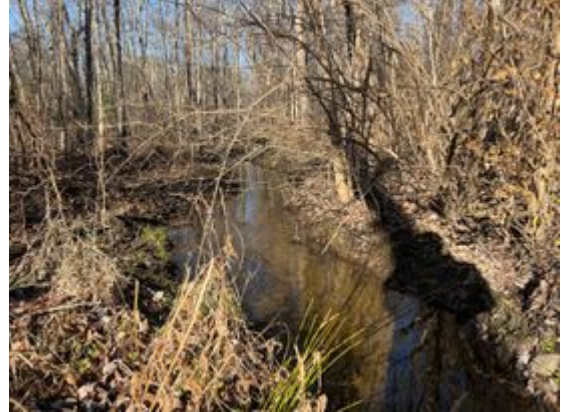
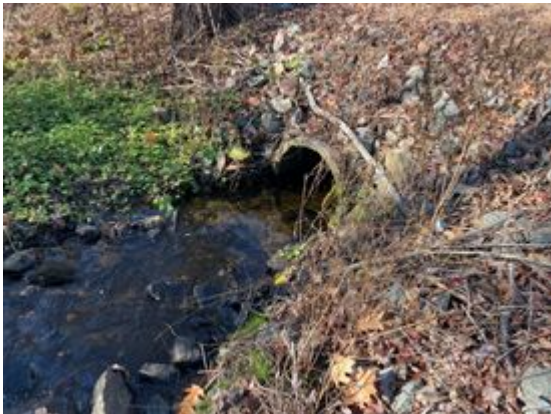
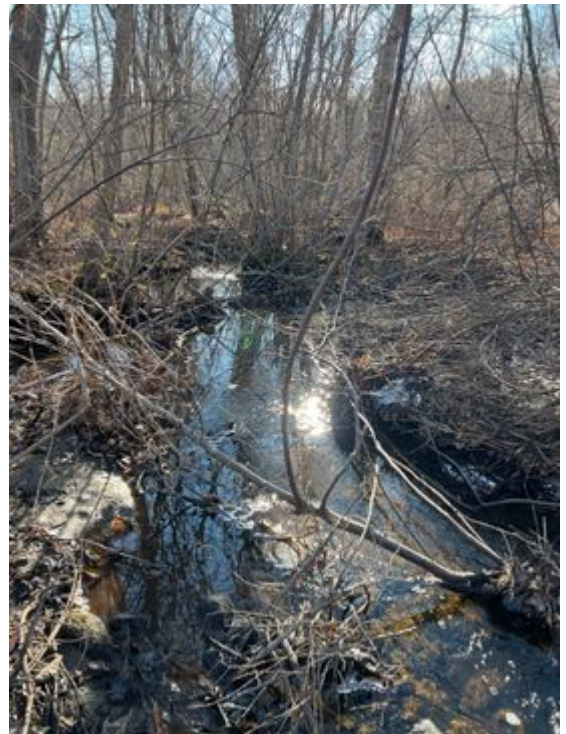
<p>USGS The National Map: National Boundaries Dataset, 3DEP Elevatio... Powered by Esri</p>		
Culvert Information (If Applicable)		
<b>Material:</b> Reinforced Concrete (RCP)	<b>Geometry:</b> Circular	<b>Number of Barrels:</b> 1
<b>Height (ft):</b> 2	<b>Span (ft):</b> 2	<b>Length (ft):</b> 35
<b>Geometry Notes (if any):</b>		
<b>Condition Observations:</b> Exposed footings, Headwall cracking, spalling, corroding, Headwall deformed or collapsing, Headwall undermining		
<b>Overall Condition:</b> Fair <i>Comments:</i> Headwall is beginning to fail. Culvert appears to be undersized which may be causing headwall issues.		
Dam Information (If Applicable)		
<b>Dam Type:</b>	<b>Control Mechanism:</b>	
<b>Control Mechanism Comments (if any):</b>

<b>Upstream Channel Information</b>	
<b>Geometry:</b> Irregular	<b>Material:</b> Vegetated / Natural
<b>Appx. Bankfull Width (ft):</b>	<b>Sedimentation Level:</b> < 10%
<b>Condition Observations</b> sedimentation, channel erosion <i>Comments:</i>	
<b>Downstream Channel Information</b>	
<b>Geometry:</b> Irregular	<b>Material:</b> Vegetated / Natural
<b>Appx. Bankfull Width (ft):</b>	<b>Sedimentation Level:</b> < 10%
<b>Condition Observations</b> sedimentation, overgrown vegetation, evidence of previous overtopping onto floodplain <i>Comments:</i>	
<b>General Recommendations (based on initial findings)</b>	
Culvert headwall is starting to collapse. Potential recommendation to repair the headwall, replace (upsized) culvert, and fix observed channel issues (i.e., downstream blockage, upstream bank erosion). It is possible channel issues are caused by undersized culvert.
