# Johnson Creek Watershed Flood Resiliency Project

## *Final Report*

Municipal Vulnerability Preparedness (MVP) Program Grant 2021, RFR ENV 22 MVP 02

**Town of Groveland**

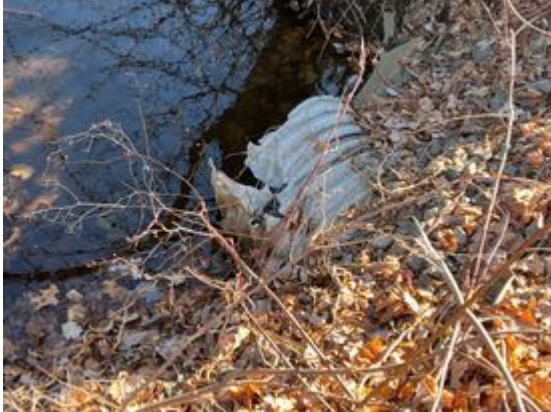
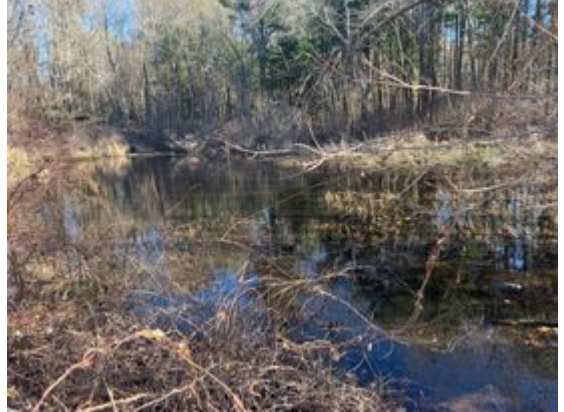
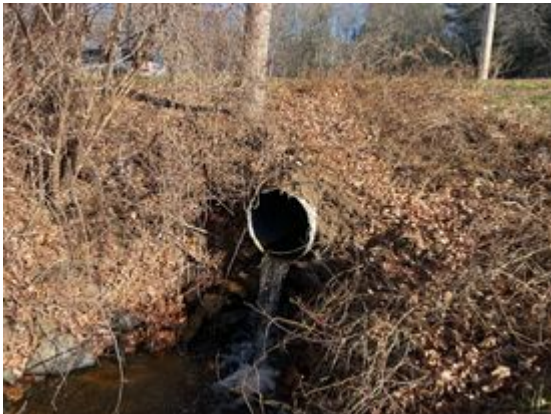
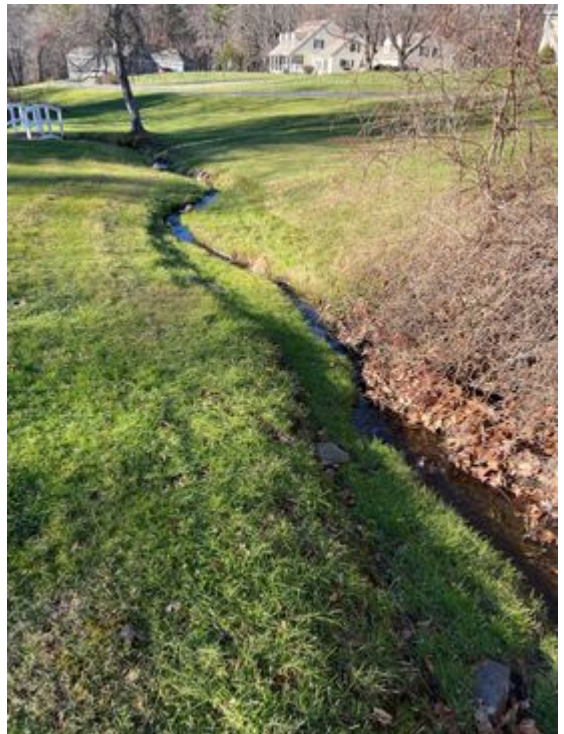
<p>USGS The National Map: National Boundaries Dataset, 3DEP Elevatio... Powered by Esri</p>		
Culvert Information (If Applicable)		
<b>Material:</b> Corrugated Metal (CMP)	<b>Geometry:</b> Circular	<b>Number of Barrels:</b> 1
<b>Height (ft):</b> 2	<b>Span (ft):</b> 2	<b>Length (ft):</b> 40
<b>Geometry Notes (if any):</b>		
<b>Condition Observations:</b> Culvert lining cracking, spalling, corroding, Culvert deformed or collapsing, Culvert undermining, Exposed footings, Perched culvert, Embankment erosion or instability		
<b>Overall Condition:</b> Poor		
<i>Comments:</i> Headwall of culvert cracked and split in half; downstream embankment appears to be eroding.		
Dam Information (If Applicable)		
<b>Dam Type:</b>	<b>Control Mechanism:</b>

<b>Upstream Channel Information</b>	
<b>Geometry:</b> Standing Water (i.e., Pond)	<b>Material:</b> Vegetated / Natural
<b>Appx. Bankfull Width (ft):</b>	<b>Sedimentation Level:</b> No observed sedimentation
<b>Condition Observations</b> no observed issues <i>Comments:</i>	
<b>Downstream Channel Information</b>	
<b>Geometry:</b> Rectangular	<b>Material:</b> Vegetated / Natural
<b>Appx. Bankfull Width (ft):</b>	<b>Sedimentation Level:</b> 10-25%
<b>Condition Observations</b> no observed issues <i>Comments:</i>	
<b>General Recommendations (based on initial findings)</b>	
Replace failing culvert and stabilize eroding downstream embankment.

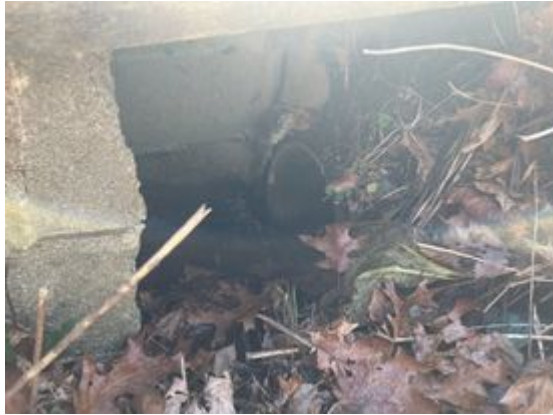
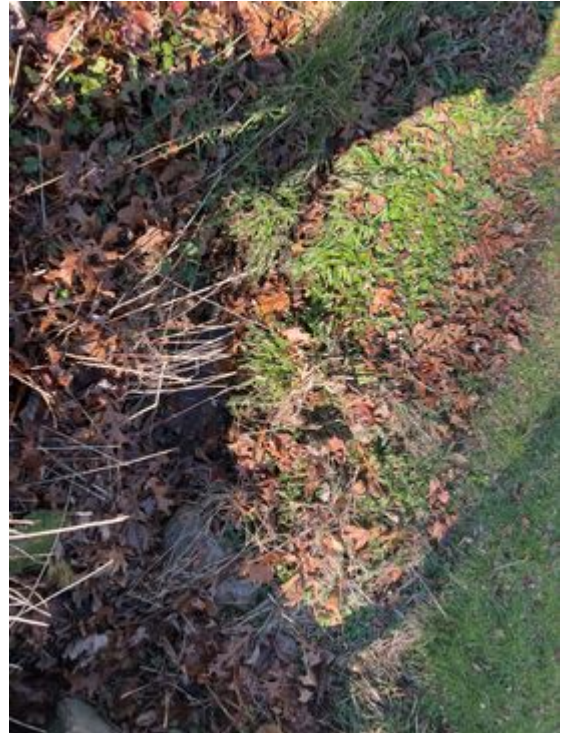
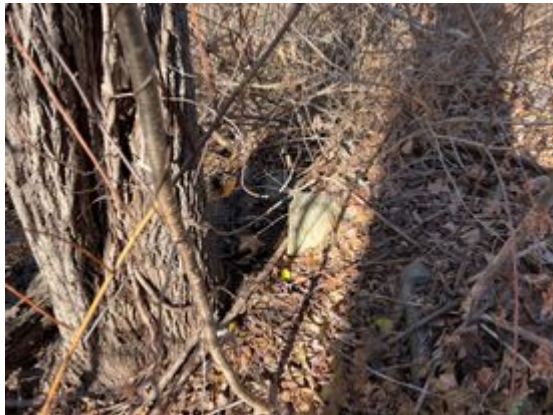
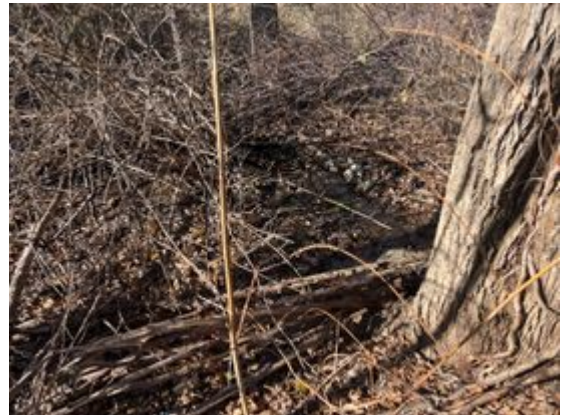
<p>USGS The National Map: National Boundaries Dataset, 3DEP Elevatio... Powered by Esri</p>		
Culvert Information (If Applicable)		
<b>Material:</b> Clay pipe	<b>Geometry:</b> Circular	<b>Number of Barrels:</b> 1
<b>Height (ft):</b> 1	<b>Span (ft):</b> 1	<b>Length (ft):</b> 30
<b>Geometry Notes (if any):</b>		
<b>Condition Observations:</b> Undersized and also set too high to adequately drain the wetlands		
<b>Overall Condition:</b> Fair <i>Comments:</i> Needs updating.		
Dam Information (If Applicable)		
<b>Dam Type:</b>	<b>Control Mechanism:</b>	
<b>Control Mechanism Comments (if any):</b>		
<b>Control Configuration Comments (if any):</b>		
<b>Outlet / Spillway Observations:</b>		
<b>Embankment Observations:</b>		
<b>Overall Condition:</b> <i>Comments:</i>

<b>Geometry:</b> Irregular	<b>Material:</b> Vegetated / Natural
<b>Appx. Bankfull Width (ft):</b>	<b>Sedimentation Level:</b> No observed sedimentation
<b>Condition Observations</b> overgrown vegetation, debris / blockage, evidence of previous overtopping onto floodplain <i>Comments:</i>	
<b>Downstream Channel Information</b>	
<b>Geometry:</b> Irregular	<b>Material:</b> Vegetated / Natural
<b>Appx. Bankfull Width (ft):</b>	<b>Sedimentation Level:</b> No observed sedimentation
<b>Condition Observations</b> overgrown vegetation, debris / blockage, evidence of previous overtopping onto floodplain <i>Comments:</i>	
<b>General Recommendations (based on initial findings)</b>	
Replace culvert at proper elevation and size.

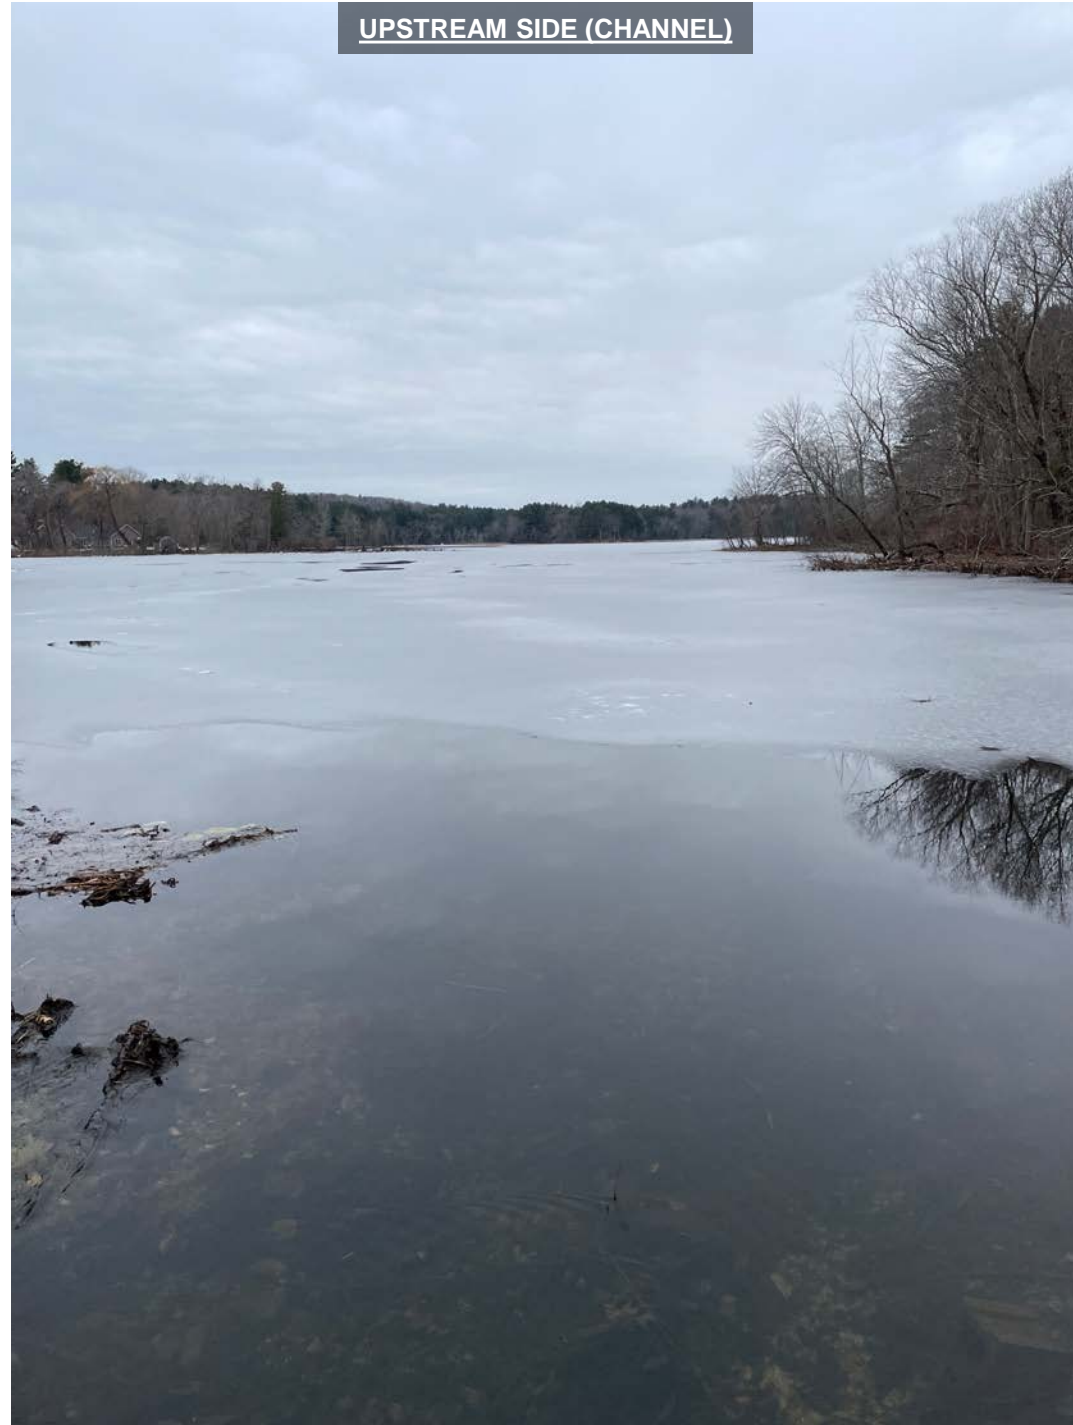
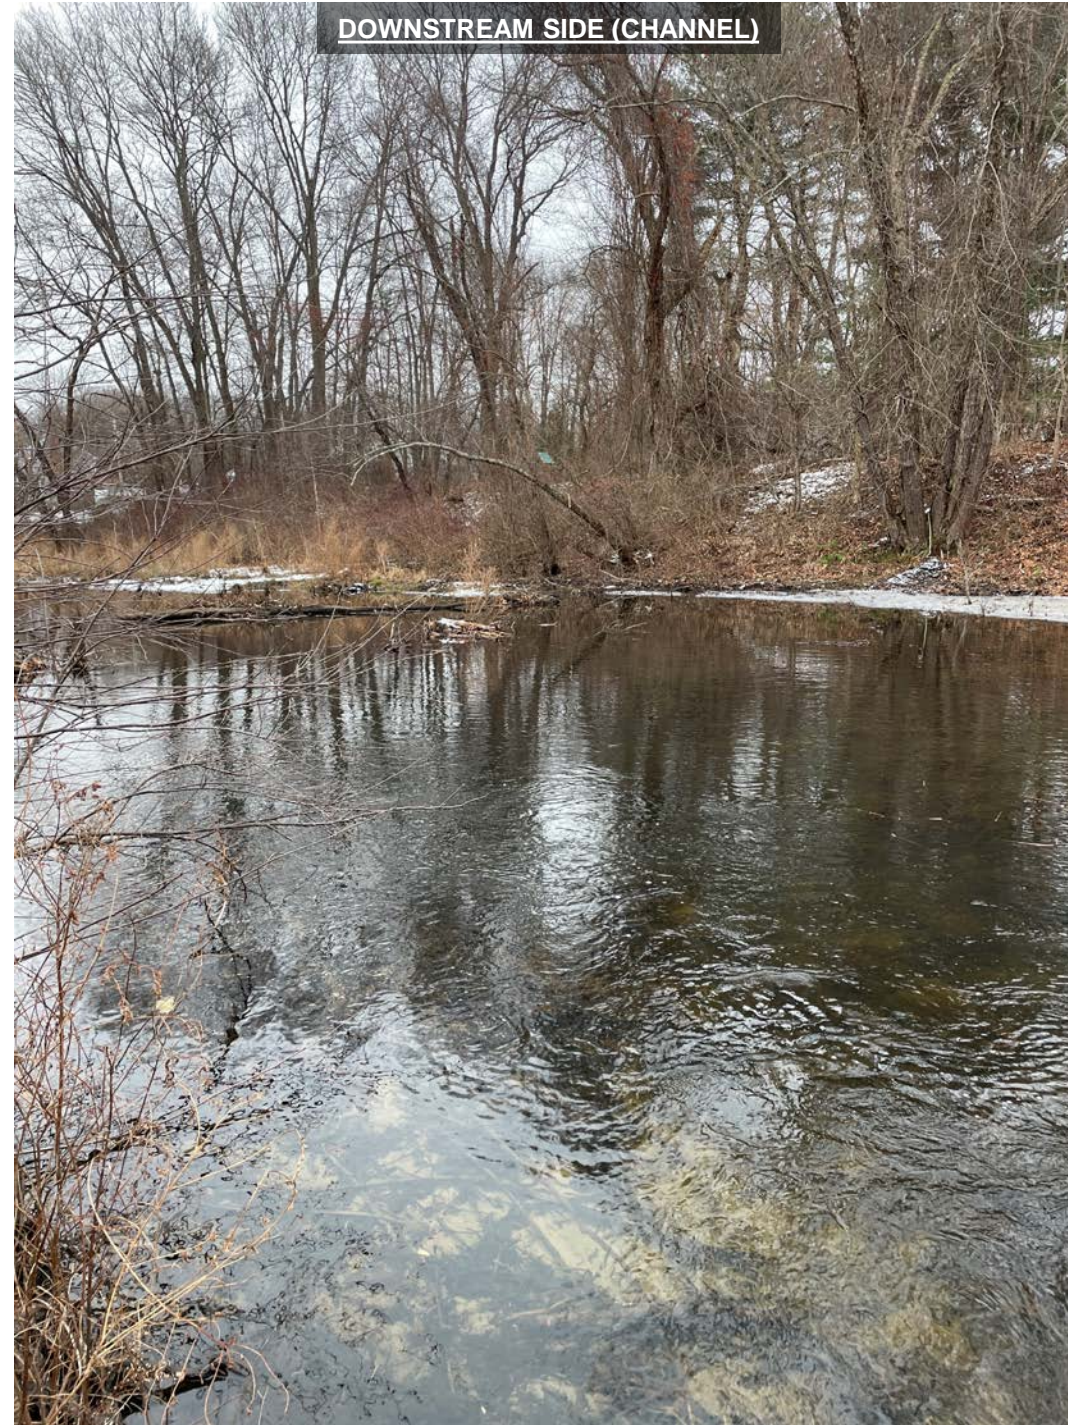
**MA01204B: Culvert Crossing on Washington Street (continued)**

- Coordinates: 42.7325, -71.0457
- Location Reference: Washington Street
- The existing crossing is an arched culvert. The culvert has a span of 6 feet, height of 4 feet. The upstream end is corrugated metal pipe (CMP). The downstream end of brick.
- The culvert outlet is in **POOR** condition.

Deteriorating Headwall and Culvert; Undersized Culvert Crossing

- Replace the existing culvert with an open-bottom culvert designed to pass the 25-year flood with 2 feet of freeboard. The proposed culvert will have a span of approximately 9 feet, height of 6 feet, and length of 40 feet.
- Address and monitor beaver activity upstream and downstream of the culvert crossing.

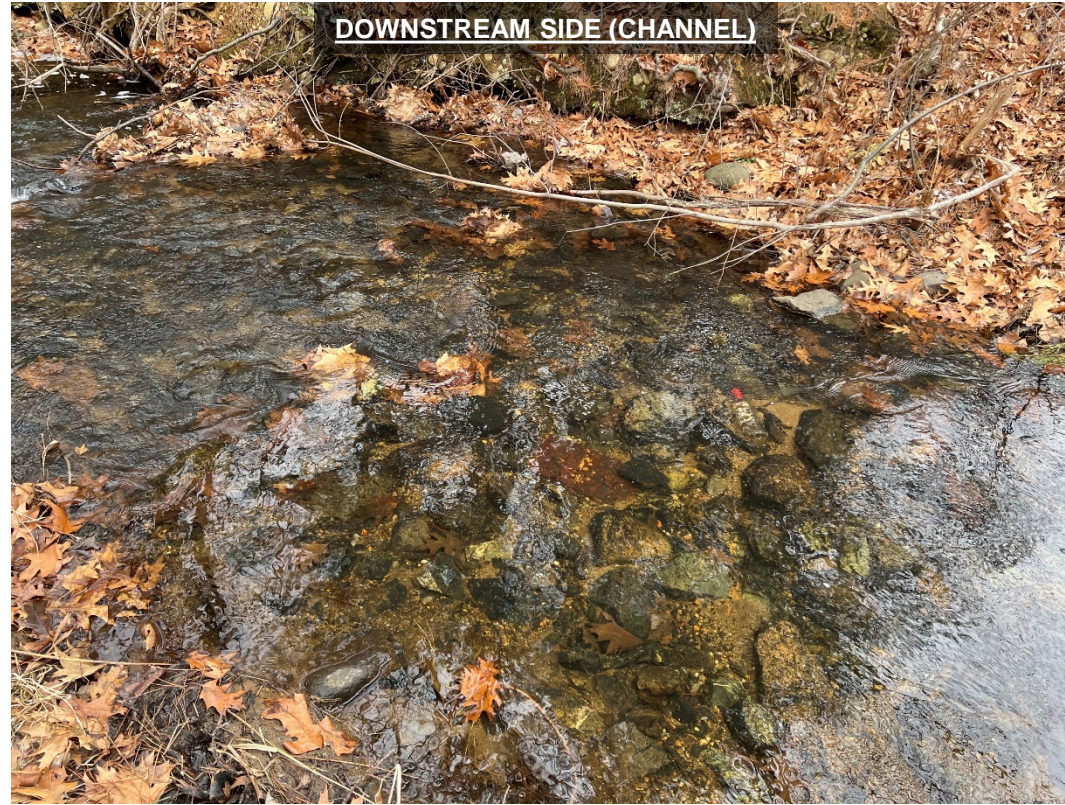
Evidence of  
Sediment  
Deposition

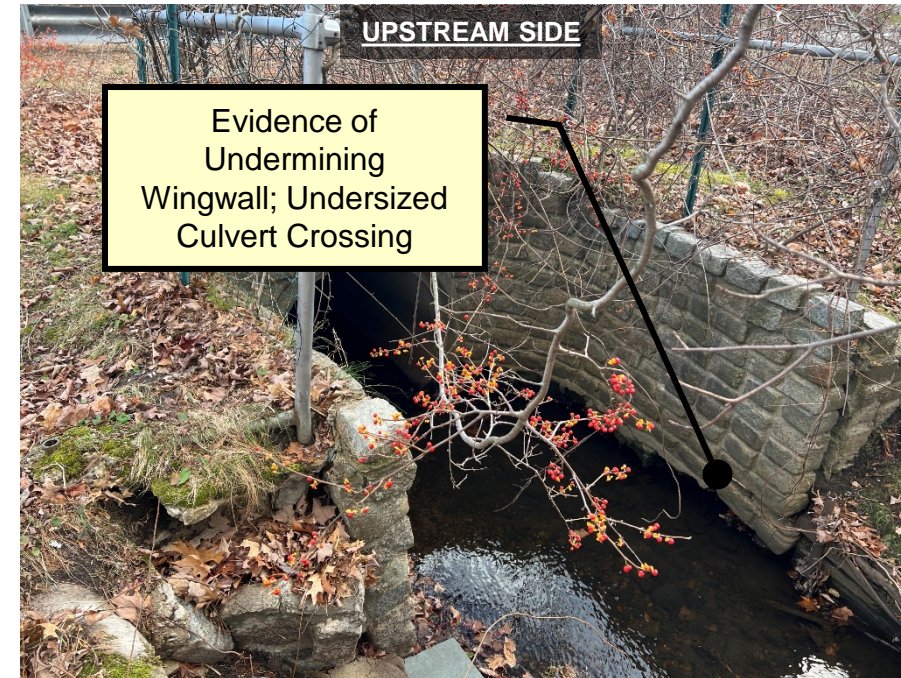
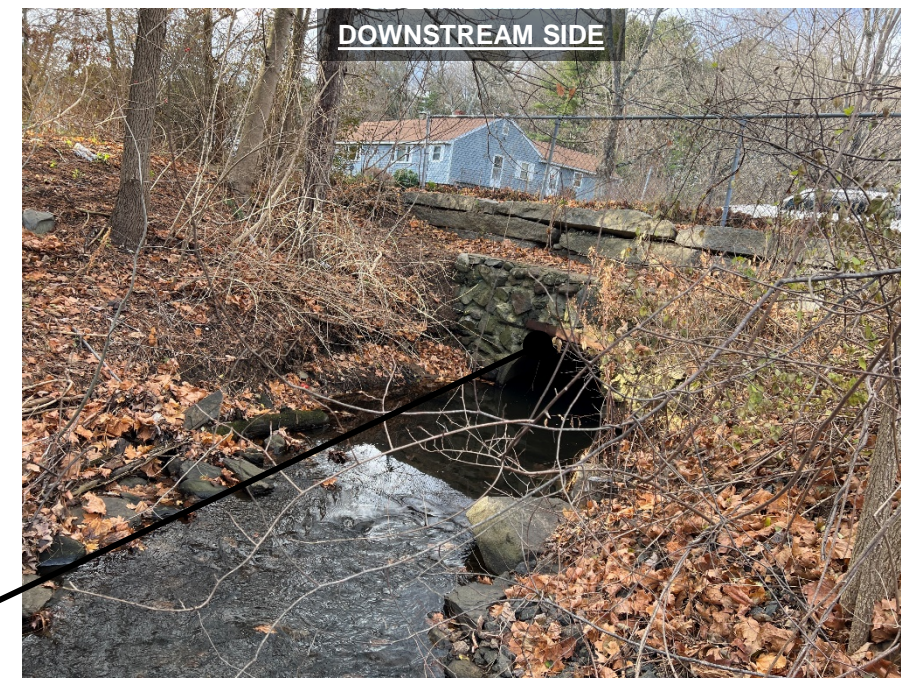
Undersized  
Culvert  
Crossing
